**PUBLIC PROCUREMENT AND DISPOSAL  
OF PUBLIC ASSETS AUTHORITY**

**CONTRACT AUDIT REPORT INTO THE CONSTRUCTION  
WORKS OF THE UPGRADE OF TE-TUGU HEALTH CENTRE  
III (CONTRACTOR: WML CONSULT & ENGINEERING  
LIMITED); AND FENCING OF ATABU HEALTH CENTRE II  
(CONTRACTOR: DREAMERS ENTERPRISES LIMITED)**

**DOKOLO DISTRICT LOCAL GOVERNMENT**

**APRIL 2026**

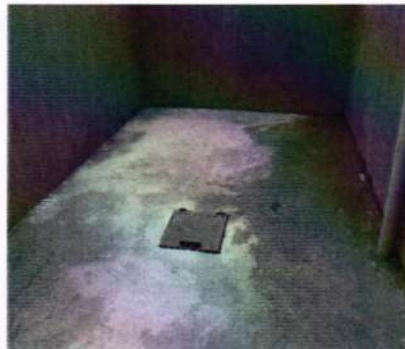
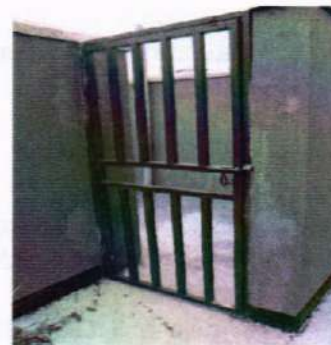
- The painting works were poorly done and incomplete yet the BOQs required the contractor to apply three coats of first grade weather-guard emulsion paint. This means that the structure will absorb moisture and organic waste, leading to the rapid decay of the concrete and potential foul odours.
- The entrance door was jammed and needed to be cleared of obstructions. Notably, this prevents health workers from disposing of biological waste safely and in a timely manner. Improper waste disposal creates significant biohazard and health risks to the community and hospital staff.

*Poor paint finishes inside and outside the placenta pit and the jammed door, respectively*

1. Immediately issue a written "Notice to Rectify" to the contractor (WML Consult & Engineering Limited) to complete the painting works and door repairs within a specific timeframe e.g., seven days.
2. Task the contractor (WML Consult & Engineering Limited) to determine if the door is jammed due to building settlement or poor installation. If the frame is warped due to structural shifting, the contractor must re-install the frame correctly rather than simply forcing the door open, as the issue will reoccur.

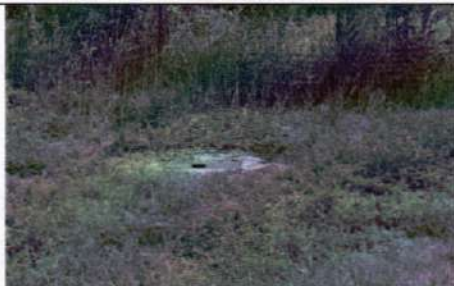
- The medical waste pit was surrounded by over grown grass which could attract vermin (snakes/rats) and create a safety hazard for health workers disposing of medical waste.
- The septic tank and medical waste pit had filled up with water before use. This will lead to potential failure upon use due to lack of capacity to handle actual waste.
- A hole was developing around the septic tank suggesting poor soil compaction during backfilling or erosion due to the topography. If left unaddressed, the septic tank could shift, the pipes could shear, or the entire structure could collapse, posing a massive biohazard and safety risk to the Health Centre.

*Medical Waste Pit surrounded by grass*

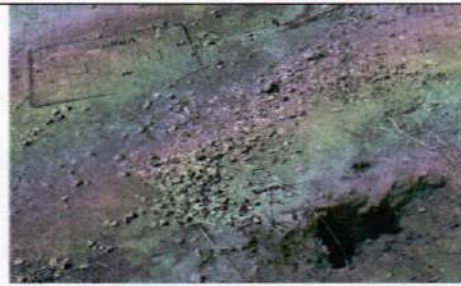
*Septic tank with a hole developing around it*

The Authority notes the clarification but emphasizes that appropriate maintenance cannot occur if the landscaping was never properly completed. Furthermore, Management's justification of topography was unsatisfactory given that the structural result is a flooded system. A properly engineered septic system must be watertight. The presence of water before use and the developing sinkhole around the structure are indicators of poor workmanship and inadequate site drainage design.

1. Conduct a water-tightness test on the septic tank and medical waste pit. If the groundwater is seeping in, the contractor must seal the structures, as this constitutes a construction defect.
2. Immediately task the contractor to:
  - i) Undertake backfilling and compaction around the septic tank to close the emerging hole. The area should be raised and graded to ensure that surface water drains away from the tank rather than pooling around it or entering it.

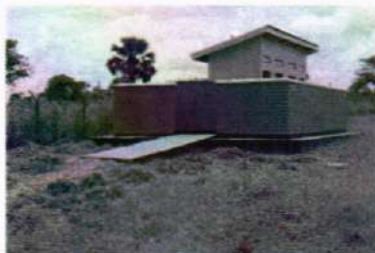
*Men's toilet entrance showing unlevelled ramp*

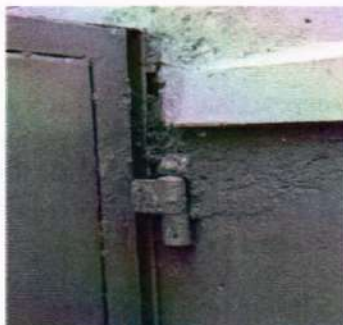
*Poor finishes and painting works*

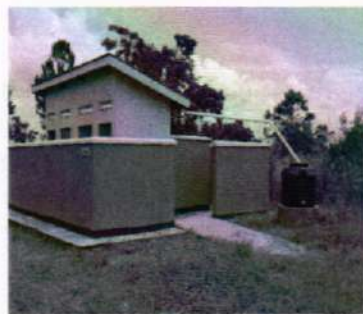
*Women's toilet entrance with ramp covered by grass hindering easy access by PWDs*

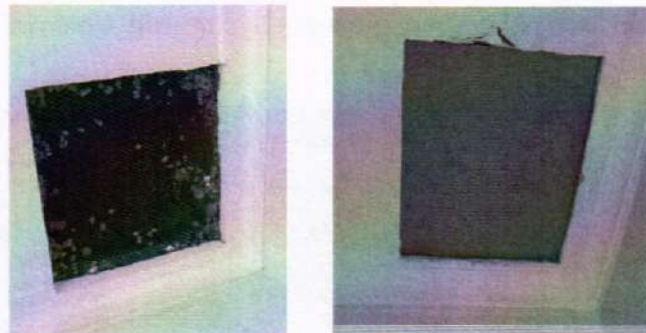
- Only two out of the three trap doors were fixed.
- One of the trap doors had mortar droplets that were not cleaned.

*The two trap doors that were installed*

2. Verify that all electrical and plumbing junction points in the ceiling are accessible via the installed trap doors. If the missing trap door prevents access to critical services, its installation must be treated as a mandatory corrective action.

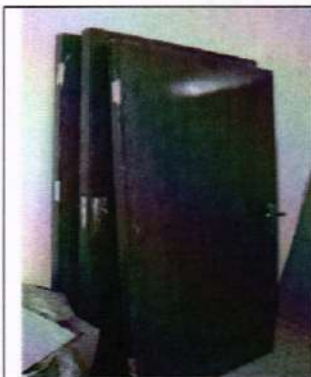
- Only six out of the nine wooden doors were installed. The remaining three doors installed were metallic instead of wood. There was no evidence that this amendment to the design of the doors was approved by the Entity. As a result, the three uninstalled wooden doors lie idle in the General Ward.
- The five-swing wooden double doors were poorly finished.
- Some of the outer steel doors were poorly finished with visible welding marks not repainted.

*Three uninstalled wooden single doors*

- ii) Formally take the three idle wooden doors into the District Stores inventory. They should be redeployed to another Government project where wooden doors are needed, or properly auctioned to recover funds, rather than being left to deteriorate in the General Ward.

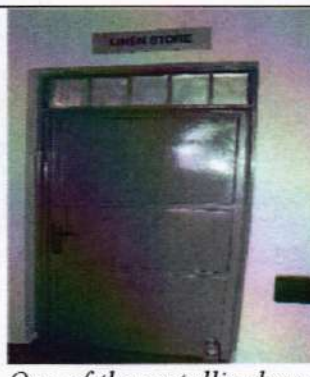
*One of the metallic doors installed at the Linen Store*

2. Task the Project Manager (District Engineer) to:
  - i) Verify if the metallic doors installed are of equivalent or higher value than the wooden ones they replaced.

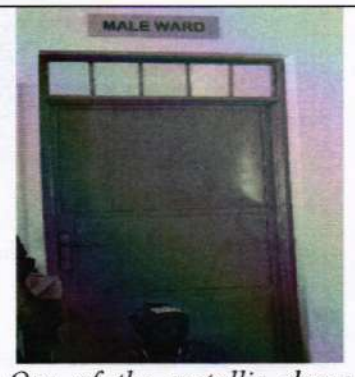
*One of the metallic doors installed at the Male Ward*

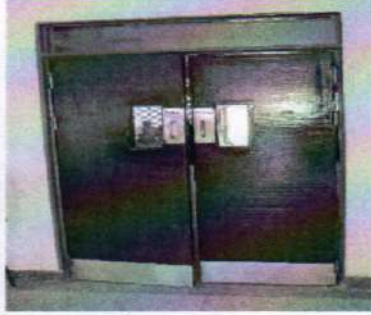
*One of the 5 swing wooden double door with poor finishes*

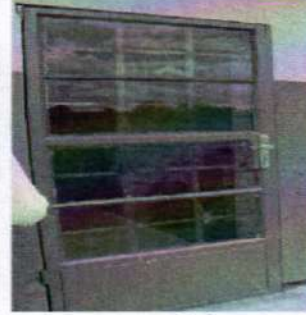
*Outer steel door with poor finishes*

- iii) Instruct the contractor (WML Consult & Engineering Limited) to:
    - a) Grind down visible welding marks on all steel doors and repaint them with high-quality anti-rust paint.

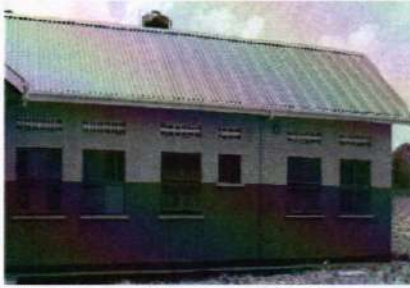
- Only 5 out of the 12 windows had sun shades contrary to the requirements in the BOQs and drawings for all the 12 windows to have sun shades.
- Some window stays and fasteners were not effectively functioning hence the Hospital Administration was forced to weld them, implying poor quality works by the contractor

Windows without sunshades

3. Task the Project Manager (District Engineer) to:
  - i) Assess whether the omission of the 7 sun shades has made the affected rooms uncomfortably hot. If the solar installations mentioned by Management do not include adequate cooling/ventilation, the contractor should be compelled to install the missing sun shades using the retention money.

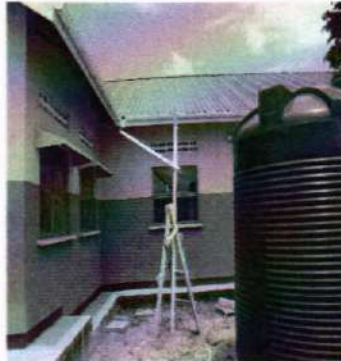
*Pipes not fixed*

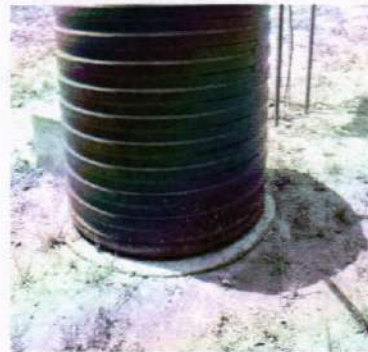
*Very short tank base*

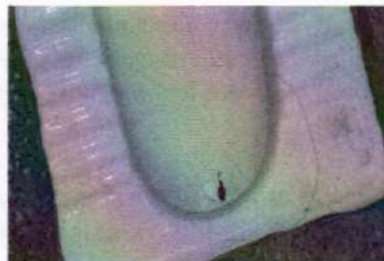
*Cracks on squatting pan*

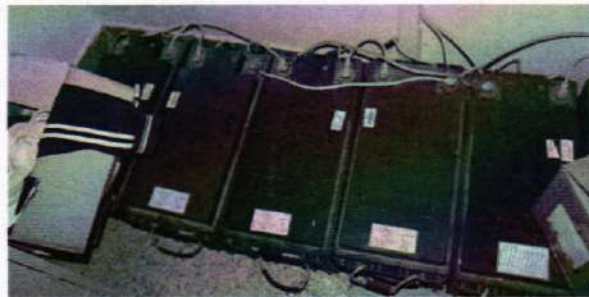
- The solar batteries were found on the ground without any supporting platform or rack.
- The Hospital In-Charge informed the audit team that the solar batteries were weak and could not support filling up of the tanks to full capacity.

*Solar batteries on the floor*

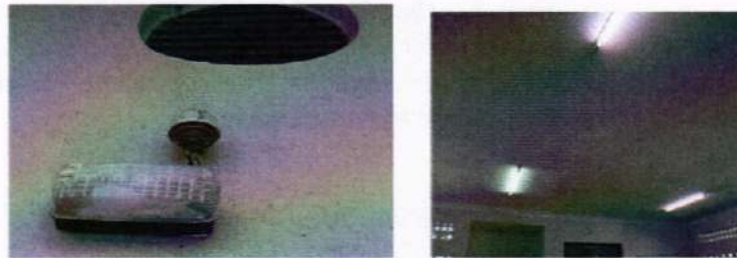
- The omission of the two security bulkhead lights creates blind spots around the health facility perimeter. This increases the risk of theft of hospital property and compromises the safety of staff and patients moving outside at night.
- The non-installation of the six LED batten lights (40% of the intended internal lighting) results in poorly lit clinical areas. Inadequate lighting can lead to medical errors, difficulty in performing minor procedures, and poor visibility for night-time patient monitoring.

*One of the security bulk head lights and single LED lights respectively*

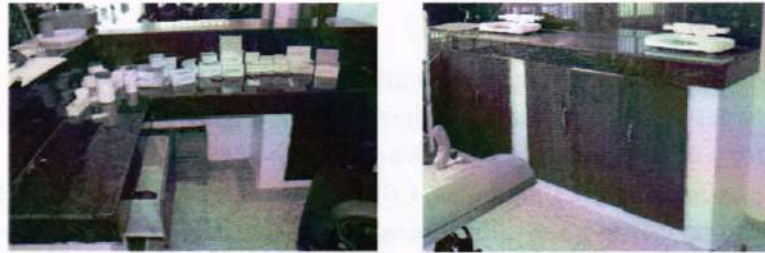
The fact that the project reached the practical completion stage with visible paint droppings and poor underside finishes, indicates that the Project Manager failed to enforce basic housekeeping and snagging protocols during the construction phase.

*Cabinets with some poor finishes*

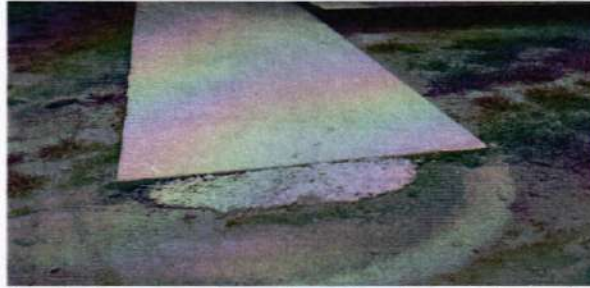
- Prevents pregnant women, elderly patients, and PWDs from accessing the Ward with ease.
- Creates a trip hazard when attempting to navigate the gap, which could lead to severe injury and potential litigation against the District.

*Improperly leveled ramp surface, deviating from technical specifications*

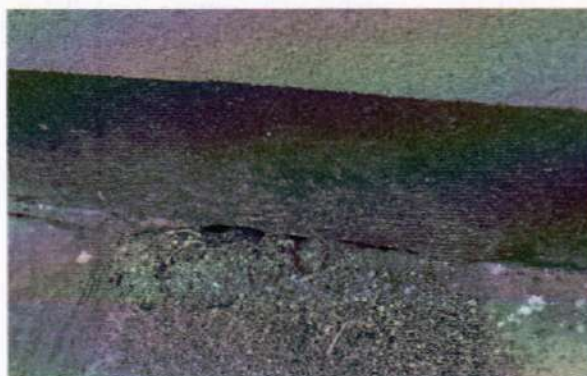
There was a gap between the external wall of the General Ward and the splash apron junction allowing rainwater to seep directly into the sub-base. Over time, this will lead to soil saturation and subsidence, which can cause the wall to settle and crack.

*Gap between the wall and splash apron*

The Authority maintains that any gap between the wall and the splash apron is a structural defect. Management's assertion that it 'does not pose any risk' ignores the long-term impact of foundation erosion and rising damp. Furthermore, the dispute regarding the authenticity of the audit photographs is noted; however, the physical evidence at the site during the time of audit, clearly showed a lack of a watertight seal.

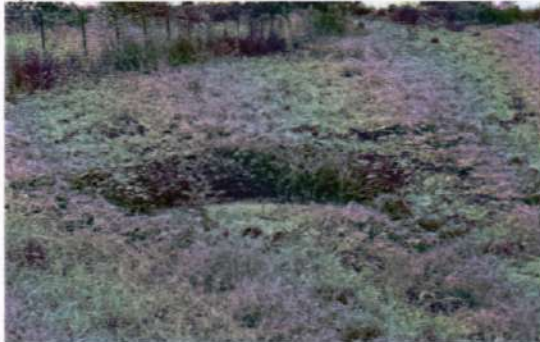
- i) Safety Hazards:** There was a critical lack of warning signage around open excavations/holes.
- ii) Environmental Restoration:** The planted grass was poorly maintained and had withered in multiple sections.

*Uncovered hole*

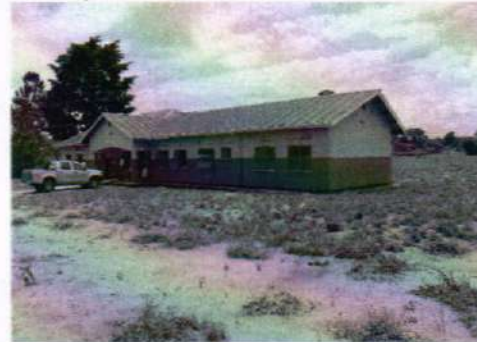
*Poor maintenance of planted grass in front of the Ward*

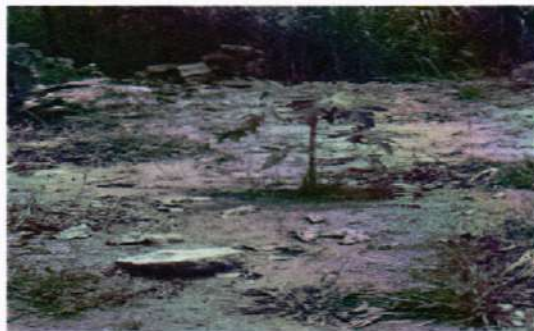
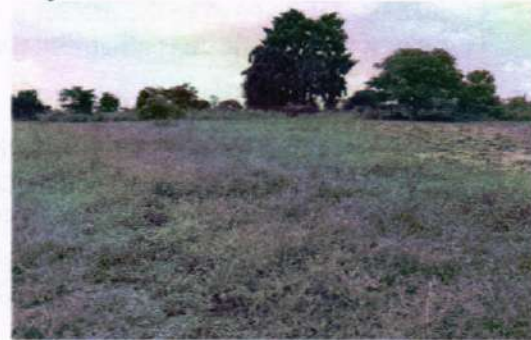
- iii) **Plant Protection:** Newly planted trees lacked the necessary protective structures or fencing.
- iv) **Final Site Grading/Leveling:** The area behind the Maternity Block remained unlevelled and overgrown with grass making the area bushy.
- v) **Site Clearance and Sanitation:** The site was not fully cleared of construction debris.

*One of the unprotected trees, debris in the back end and unlevelled landscape behind the Ward respectively*

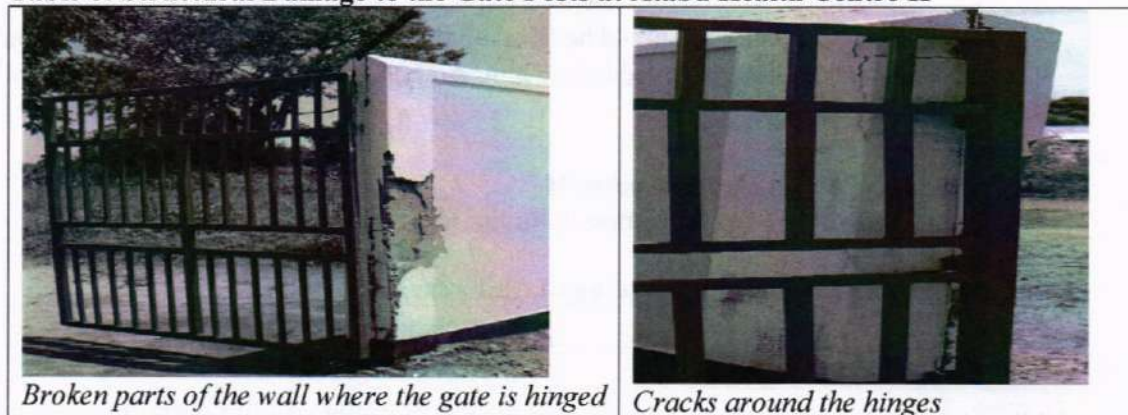
**Table 6: Structural Damage to the Gate Posts at Atabu Health Centre II**

While the Facility In-Charge reported that the damage resulted from a security breach in January 2025 involving an attempted illegal entry, the Authority noted a lapse in quality assurance. Specifically, the bills of quantities provided a provisional sum of UGX 500,000 for onsite testing of concrete products by the Project Manager; however, there was no evidence that these tests were ever conducted.

*Broken parts of the wall where the gate is hinged*

*Cracks around the hinges*

- i) The Project Manager should be held liable for professional negligence regarding the bypass of mandatory quality control tests.
  - ii) The contractor (Dreamers Enterprises Limited) should be held liable for all repair costs. Given that the structural failure resulted from a deliberate bypass of BOQ concrete testing, it is classified as a latent defect. Consequently, the contractor remains liable for remediation even after the expiry of the Defects Liability Period.
