**CONTRACT AUDIT REPORT INTO THE CONSTRUCTION
OF ABONGOMOLA SOLAR PIPED WATER SCHEME-
PHASE I (CONTRACTOR: DREAMERS ENTERPRISES
LIMITED)**

KWANIA DISTRICT LOCAL GOVERNMENT

MARCH 2026

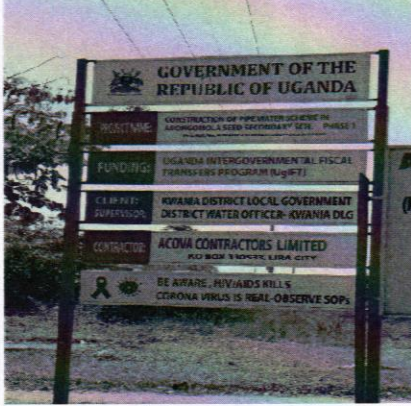
<p><i>Only one out of the two project signboard was installed</i></p>	<p><i>Wash-out pipe left uncovered</i></p>

- ii) Install the second project signboard at the designated place, otherwise, recover UGX. 900,000 worth of the signboards from the retention monies.

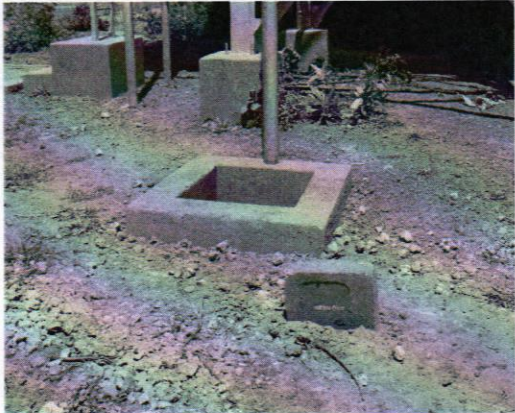
- An uncovered wash-out pipe can result in foul odors and severe plumbing damage due to exposure to debris, rainwater, and pests.

4. Issue a 14-day "Notice to Correct" to the contractor, Acova Contractors Ltd. to:
 - i) Secure the tower and cover the wash-out pipe at their own cost. If the contractor fails to respond within 7 days, the Entity should use the UGX. 17.5M retention to procure another contractor for the repairs.

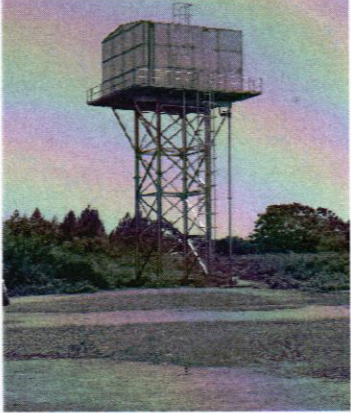
The Authority noted that the contractor failed to undertake site restoration, leaving the area adjacent to the soak pit un-backfilled and creating a dangerous open depression that is a public safety hazard. Furthermore, the site remained un-levelled and lacked the mandatory post-construction landscaping, in direct violation of the technical specifications for site handover.

<p><i>Storage Reservoir with landscaping and fencing around it not done</i></p>	<p><i>Missing nut on the 10m steel reservoir tower supporting the 80m³ tank.</i></p>

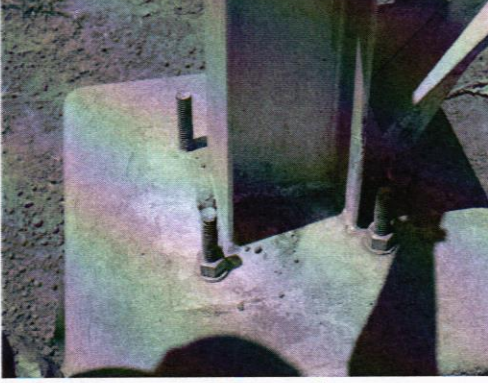
- The spoiled motor indicated improper installation or maintenance, such as running the pump dry, debris accumulation (sand/silt), or power surges.
- A missing bolt on a tower holding 80 tons of water creates a risk of structural collapse, which could lead to fatalities and total asset destruction.

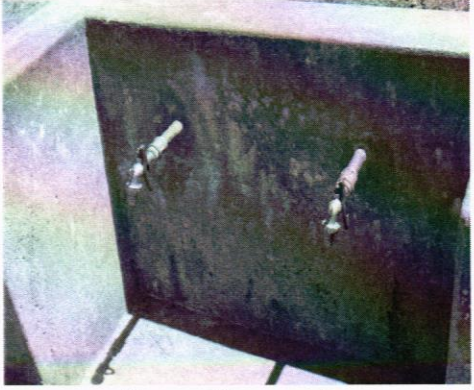
- i) **Total System Failure:** The scheme is non-functional due to a motor burnout. Consequently, all water pumping operations ceased.
- ii) **Structural Defect:** A critical nut was missing from the 10m steel reservoir tower supporting the 80m³ tank.
- iii) **Deliverable Shortfalls:** Only one project signboard was installed contrary to the BoQ requirement that required two signboards costed at UGX. 900,000 each. Secondly, the Operating and Maintenance manuals (UGX. 200,000) and As-Built drawings (UGX. 500,000) were not submitted by the contractor.
- iv) **Incomplete Finishing:** The pump station and equipment were not engraved for identification, and the wash-out pipe was left uncovered.

- Despite paying UGX. 324M, the Return on Investment (ROI) is zero as the pump is inactive.
- The lack of piped water affects sanitation, hygiene, and overall welfare, for the community that depends on the system for daily water needs.

<p><i>Taps with no water</i></p>	<p><i>Area adjacent to the soak pit that was not backfilled</i></p>

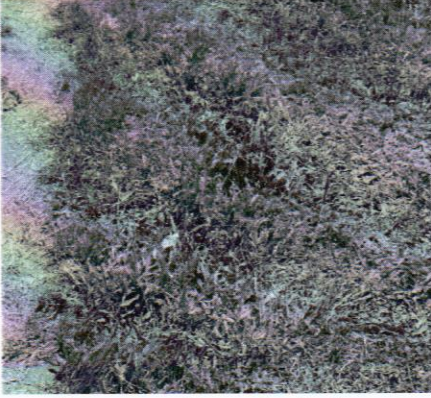
- Improper backfilling can lead to soil erosion or water pooling, which may eventually undermine the structural stability of the soak pit or nearby foundations.
- The soak pit at the school site poses a significant physical danger to the public and students.
- Failure to level the site and implement environmental protection works will lead to soil erosion and potential water source contamination.
- Lack of professional oversight led to unmitigated environmental and social risks, including un-backfilled pits and poor site leveling, in violation of both building codes and occupational safety protocols.

2. Task the Contract Manager (District Water Officer) to instruct the contractor, (Acova Contractors Ltd.) to:
 - i) Install safety tape or temporary fencing around the depression until backfilling is complete.

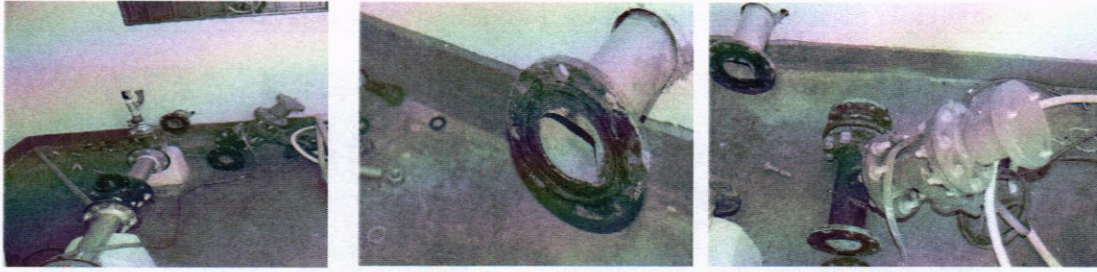
- *Inspection and pump testing was also conducted and it was realized that the pump got burnt during sudden slight reduction in dynamic water level as a result of the dry spell. The pump was lowered down at an extract depth of 17metres.*
- *We pledge to compel the contractor to install the second sign post and to provide manuals and As-Built drawing, otherwise, we will recover UGX 900,000 and UGX 700,000 shillings from the retention money if the contractor fails to comply.*

Spoiled pump

1. Conduct a physical site verification with the Contract Management Team and the Internal Auditor to confirm the replacement of the pump motor and submit a formal System Restoration Certificate signed by both the Contractor and the CMT confirming that the scheme is now pumping at the required discharge rate. Otherwise, the UGX. 17,555,882 retention should be withheld until the system is fully operational and structurally certified.

5. Inspect the entire water system, including the pump end and controller, to identify the root cause of motor burnout to prevent a reoccurrence of the same failure.

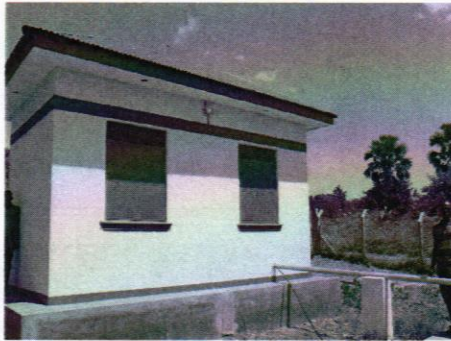
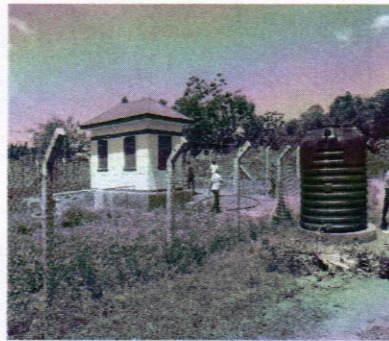
- Unengraved pump stations and equipment hinder rapid identification and emergency response, thereby delaying system shutdowns during failures. This lack of clear marking also creates a high risk of operational error or equipment mismanagement, which could result in catastrophic system damage/failure.

Unengraved pump station

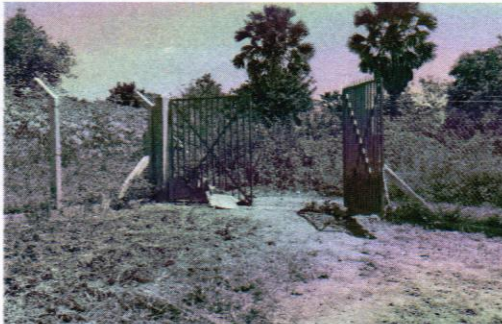
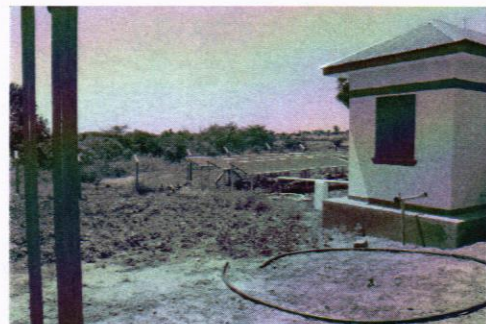
Landscaping and levelling not done at the pump station
