CONTRACT AUDIT INTO THE CONSTRUCTION OF CONSTRUCTION OF A NEW HEALTH CENTRE III AT GOT APWOYO IN NWOYA DISTRICT LOCAL GOVERNMENT UNDER UGIFT PROGRAM: PROCUREMENT REF: MOH/UGIFT/WRKS/2023/2024/00008 (LOT 15)

CONTRACTOR: ALIKO CONSULTS LTD.

JULY 2025

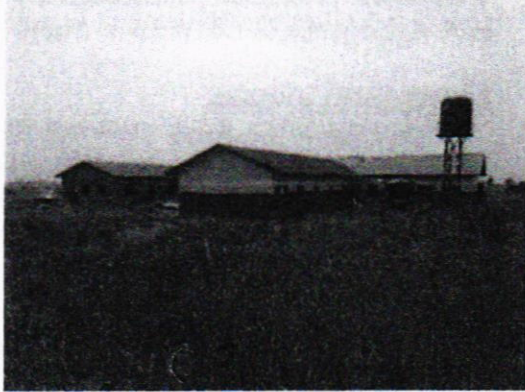
<p data-bbox="858 689 1385 925">In the construction of the Outpatient Department, the contractor had cast terrazzo on the concrete benches and sink tops that needed grinding, and was yet to finalise the plumbing work and electrical installations, fit the window glasses, internal doors and complete the paint work.</p>
iii.	2 Staff houses	249,655,291

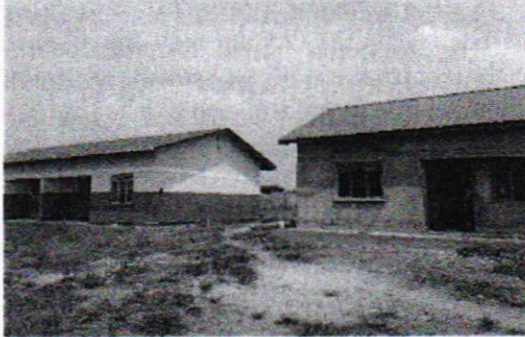
<p data-bbox="858 1272 1385 1574">Review of the construction works in the staff houses, showed the contractor had completed one block of the staff house, but the paint work was poorly done. The other block was incomplete and the contractor was yet to do; paint work, terrazzo work, complete the plumbing work, electrical installations and the drainage system, and fit the internal doors and glasses.</p>

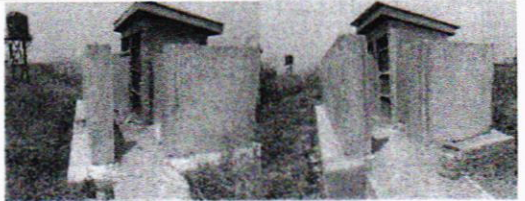
<p data-bbox="858 1787 1385 1912">The construction works in the 2 stance VIP latrines was incomplete and the contractor was yet to do; paint work, finish the apron and the ramp.</p>

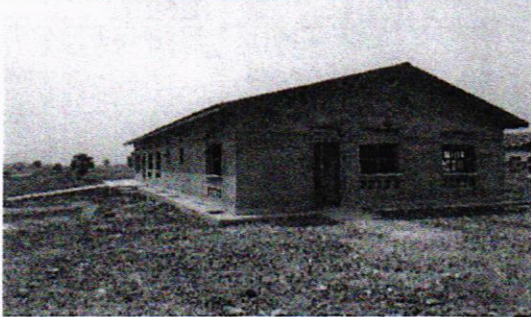
<p>The contractor had not done external works on the walkways, storm water drainage systems. Landscaping had been commenced with little progress achieved.</p>
Total		807,292,848

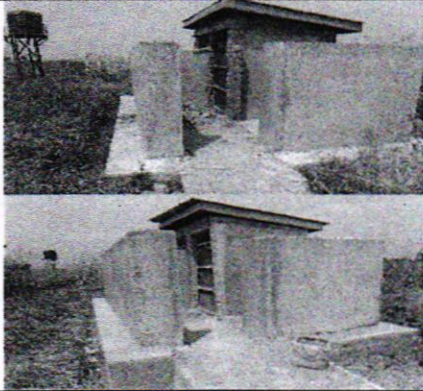
3.	2 – Units of stance VIP latrine for staff house.	35,423,762	The internal and external finishes work that were yet to be done, included: i. Painting ii. Completing plastering; iii. Backing filling and leveling the aprons

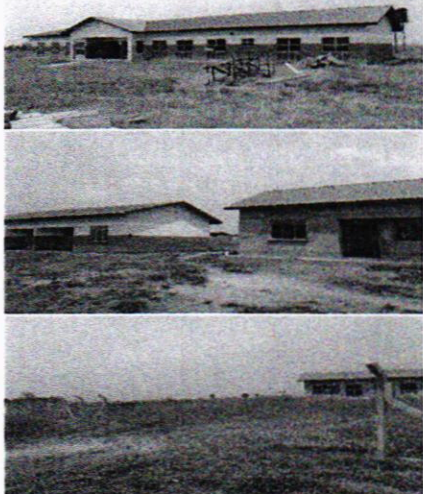
4.	External works	104,077,000	The external works that were yet to be done, included: i. Walkways, ii. Landscaping, iii. Gate installation; and iv. Storm water drainage.

The Contract Manager should submit the project completion report to the Accounting Officer to guarantee that the contractor completed all the project works within the extended timeline i.e., 30th April 2025, as per the Accounting Officer's letter dated 23rd December 2024 to the contractor, Aliko Consults Ltd.

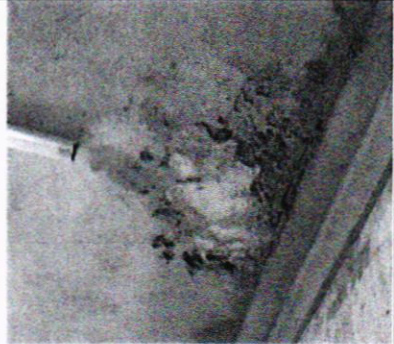
S/N.	Project milestone	Contract value (UGX)	Defects identified during the audit.	Site photos of the audit findings.
A	Outpatient Department / Administration	334,413,033		
1.	Concrete ceiling		<p>There was poor finishing work done on the ceiling of the structure.</p> <p>Recommendation The Project Manager should instruct the contractor to redo the finishing works on the ceiling.</p> <p>Management response</p> <p>Authority's comment No response.</p>

The Project Manager should submit a defect correction report to the Accounting Officer guaranteeing that the contractor corrected all the defective works above in the staff house and Outpatient Department / Administration i.e., the cracked floors, veranda, paint work, and replace the internal doors and cabinet doors, among others with the appropriate quality specified in the BOQ.

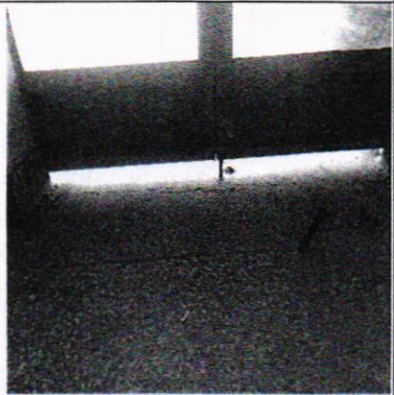
2.	Windows and external doors		<p>Main entrance metallic door installed had a big gap between the bottom of the door & the floor.</p> <p>Recommendation The Project Manager should instruct the contractor to seal the gap in the main entrance door.</p> <p>Management response</p> <p>Authority's comment</p>

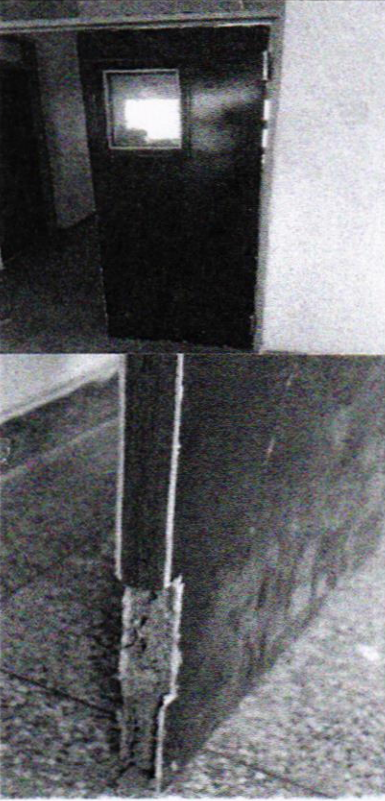
S/N.	Project milestone	Contract value (UGX)	Defects identified during the audit.	Site photos of the audit findings.
			No response	
3.	Internal doors		<p>Internal flush doors installed:</p> <ul style="list-style-type: none"> i. Had large gaps between the door panel and the door frame. ii. Were of poor quality, as the woodcuttings were loose and could not hold the door hinges. iii. Material used was not solid mahogany as was specified in the BOQ; element 7, Item A. <p>Recommendation The Project Manager should instruct the contractor to replace all the internal doors, with the quality of doors specified in the BOQ, in both the Outpatient Department (OPD) and the staff house.</p> <p>Management response <i>A snag list of this was prepared and given to the contractor for correction.</i></p> <p>Authority's comment The Authority notes the response, however, the snag list submitted as evidence was for another Health Centre, i.e., Todora HCIII maternity ward construction and not for Got Apwoyo HCIII.</p>

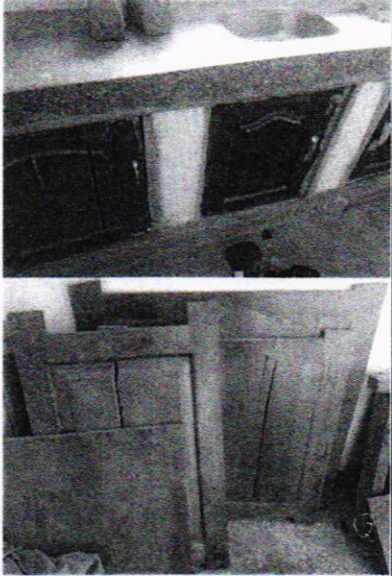
S/N.	Project milestone	Contract value (UGX)	Defects identified during the audit.	Site photos of the audit findings.
4.	<p>Fittings & Fixtures.</p> <p>The installation work is at completion. However, poor quality fitting and fixtures, and doors have been installed, in the Out Patient Department building.</p>		<p>Cabinet doors installed were:</p> <ul style="list-style-type: none"> i. Cracked; ii. Of poor-quality timber; and iii. Poorly installed. <p>Recommendation The Project Manager should instruct the contractor to replace all the cabinet doors, with the quality of doors specified in the BOQ.</p> <p><u>Management response</u></p> <p>Authority's comment No response</p>

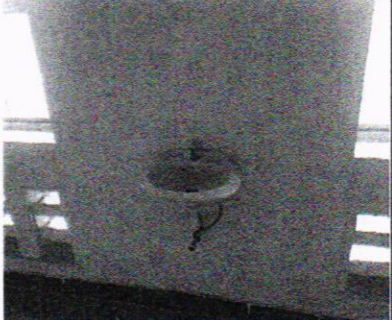
<p>Hand wash bowls installed was small size.</p> <p>Recommendation The contractor should replace the hand wash bowls as specified in the BOQ</p> <p><u>Management response</u></p> <p>Authority's comment No response</p>

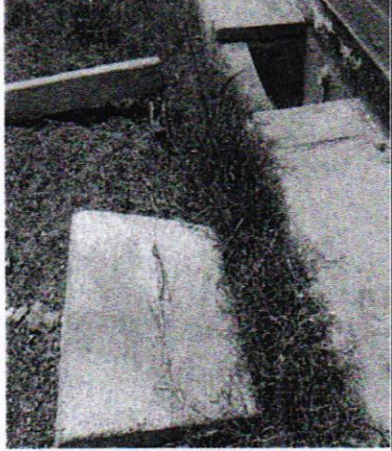
<p>Manhole cover that was to be installed had cracked at the centre.</p> <p>Recommendation The contractor should replace the manhole covers with the quality of specified in the BOQ.</p> <p><u>Management response</u></p> <p>Authority's comment No response</p>

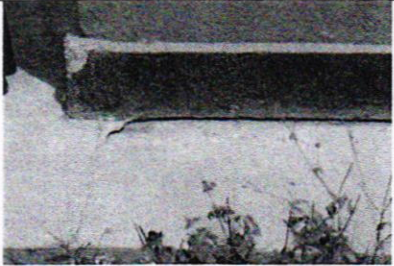
S/N.	Project milestone	Contract value (UGX)	Defects identified during the audit.	Site photos of the audit findings.
B	Staff house	249,655,291		
1.	Defects identified in the concrete apron		<p>Poor finish work had been done as:</p> <ul style="list-style-type: none"> i. The verandah slab had separated from the main wall; ii. Plaster pilled off; iii. Three coats of paint were not applied on the building.

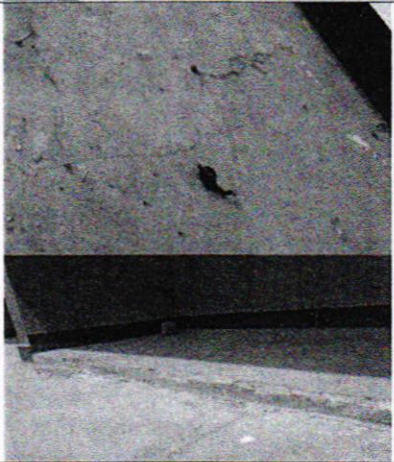
2.	Poor paint work and floor finishes		<p>Poor paint work was done inside the house i.e., the painted surfaces were not smooth/soothing.</p>

<p>Floor finishes;</p> <ul style="list-style-type: none"> i. The internal cement screeded floors had cracked; and ii. The verandah cement screed easily pilled off and were broken at the entrance.

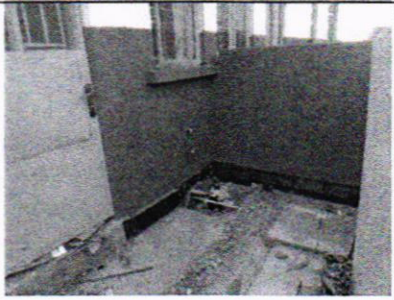
<p>Poor quality paint work was done on the behind balcony, as it had:</p> <ul style="list-style-type: none"> i. Pilled off; ii. Three coats of paint were not applied on the building; and iii. The external door had a sizeable gap from the floor, and as can be seen on the photo, papers were used to fill the gap.

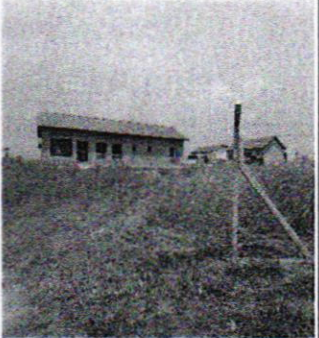
S/N.	Project milestone	Contract value (UGX)	Site status during the physical verification on 10 th January, 2025	Site photos of the audit findings.
1	Security management (Item D).	4,000,000	The site security was poor i.e., <ul style="list-style-type: none"> • No gate was installed by the Contractor at the site; and • No temporary security house and personnel were deployed to manage the security around the site and at the entrance(s).

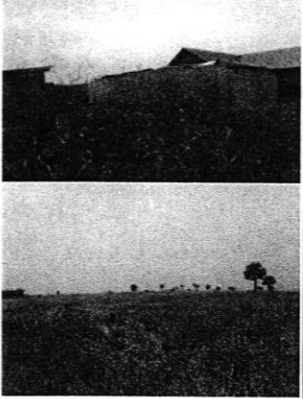
<p>The environment as was around the site</p>

S/ N	Project milestone	Amount (UGX)	Site status at physical verification on 10 th January, 2025	Site photos of the audit findings.
1	Health and safety (Item E)	2,500,000	Site was bushy and some structures were covered in bush as seen in the photos.
