**CONTRACT AUDIT REPORT INTO THE CONSTRUCTION OF RENGEN  
SEED SECONDARY SCHOOL IN KOTIDO DISTRICT UNDER UGIFT  
PROGRAM**

**CONTRACTOR: MANGRON INVESTMENT LTD**

**PROCUREMENT REF: MOES/WRKS/21-22/00003/Lot 23**

**AUGUST 2025**

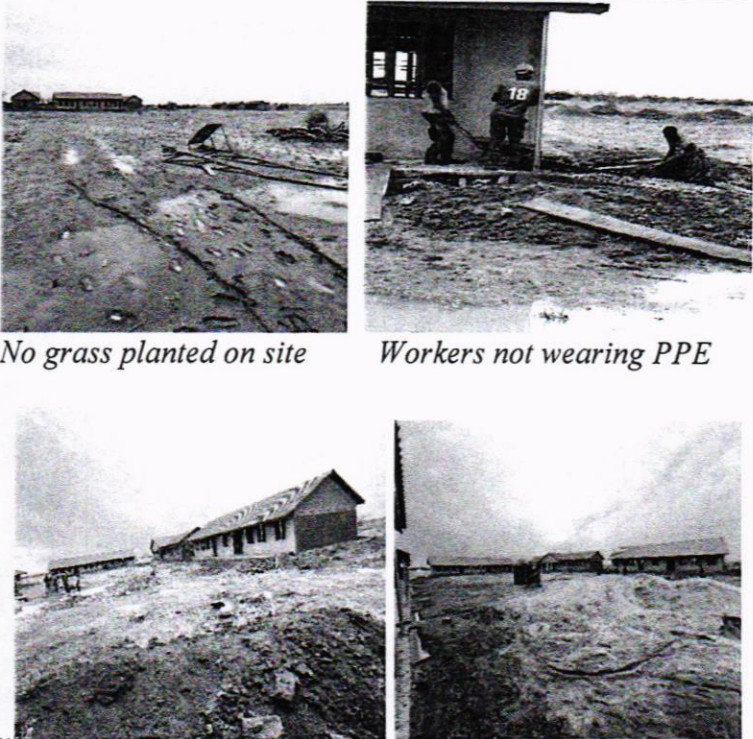
| Item | Pending works | Pictorial evidence |
|---|---|---|
| <p><b>Preliminaries</b></p> | <p><b>Non-compliance with occupational health and safety requirements;</b></p> <ul style="list-style-type: none"> <li>• No hoarding of site</li> <li>• Site levelling and planting of grass not done</li> <li>• Workers not in PPEs</li> <li>• No first aid kit</li> <li>• No signages</li> </ul> | <p><i>No grass planted on site</i>      <i>Workers not wearing PPE</i></p> <p><i>Site not hoarded off</i>      <i>Site not levelled</i></p> |

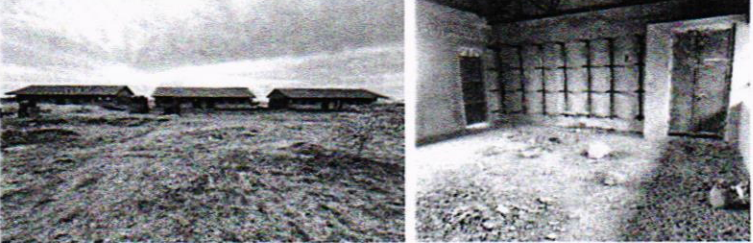
| Item | Pending works | Pictorial evidence |
|---|---|---|
| <p><b>Three 2-classroom blocks</b></p> | <p><b>Slow progress of works pending;</b></p> <ul style="list-style-type: none"> <li>• Internal and external finishes,</li> <li>• Floor works,</li> <li>• Painting,</li> <li>• Electrical installations,</li> <li>• Rump installations,</li> </ul> | <p><i>Incomplete 3 classroom blocks with no painting and inside one of the classrooms pending floor finishes, painting, and electrical installations</i></p> |

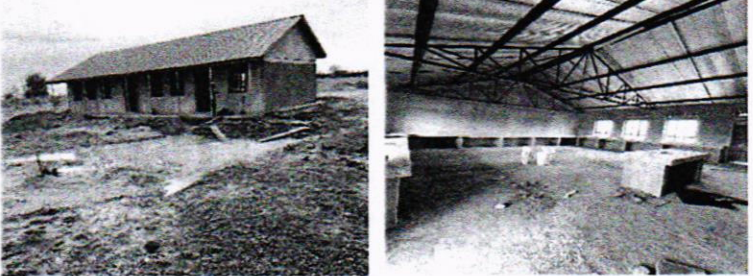
| Item | Pending works | Pictorial evidence |
|---|---|---|
| <p><b>One 2-Unit Science Laboratory Block</b></p> | <ul style="list-style-type: none"> <li>• Window panes,</li> <li>• Rain water gutters,</li> <li>• Furniture installation,</li> <li>• Lightening arresters.</li> </ul> | <p><i>Science lab not painted and floor works not finished</i></p> |

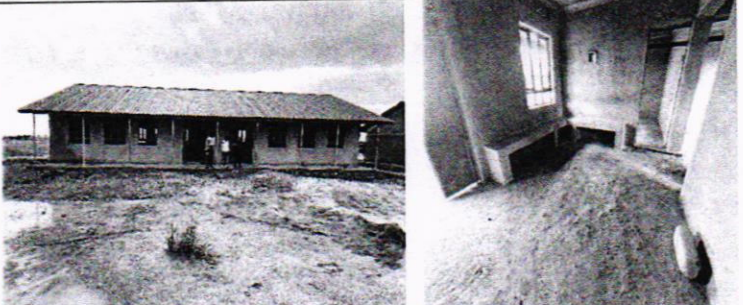
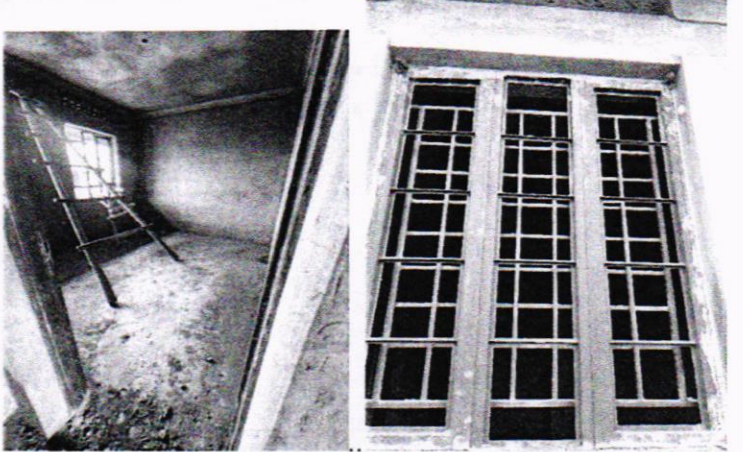
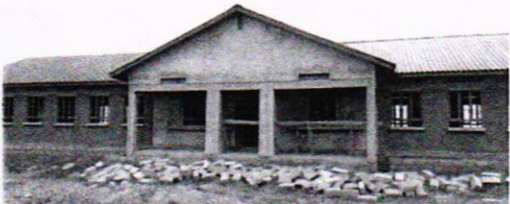
| Item | Pending works | Pictorial evidence |
|---|---|---|
| <p><b>One Administration Block</b></p> | | <p><i>Unpainted Administration block waiting area floor not finished</i></p> <p><i>Incomplete interior works window frame with no glasses</i></p> <p><i>No rain water gutters installed</i></p> |

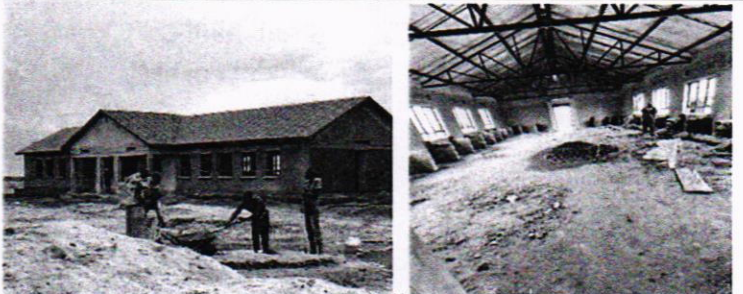
| Item | Pending works | Pictorial evidence |
|---|---|---|
| <p><b>One ICT and library Block</b></p> | | <p><i>ICT and library Block not painted and incomplete interior works</i></p> |

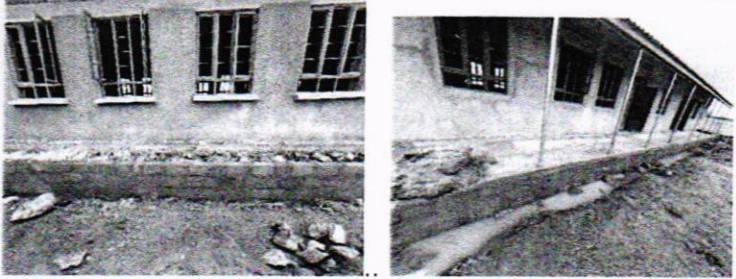
| Item | Pending works | Pictorial evidence |
|---|---|--|
| | | <p data-bbox="776 523 1539 557"><i>Incomplete splash apron works drainage works not yet done</i></p> |

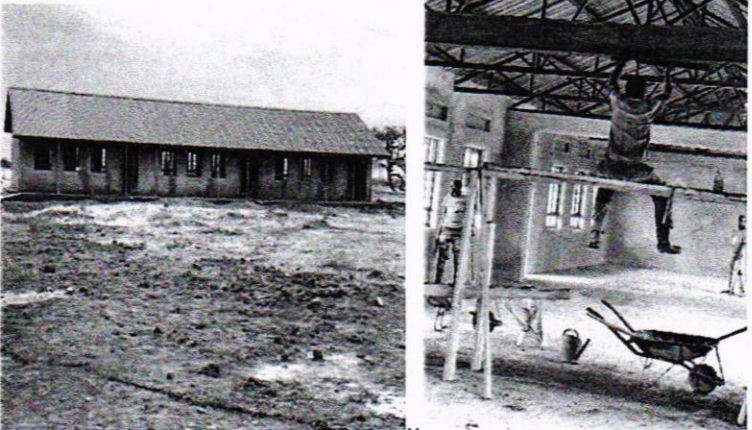
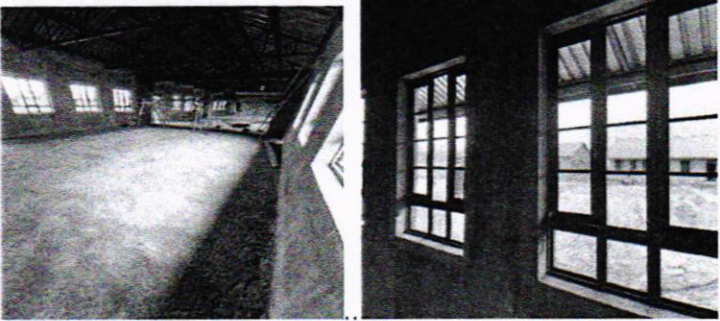
| Item | Pending works | Pictorial evidence |
|---|---|--|
| <p data-bbox="233 562 428 671"><b>One Multipurpose Hall</b></p> | | <p data-bbox="776 1006 1539 1045"><i>Multi-purpose hall with incomplete works on floor and wall</i></p> <p data-bbox="776 1381 1539 1453"><i>Inside the multi- purpose hall with no painting and window panes</i></p> |

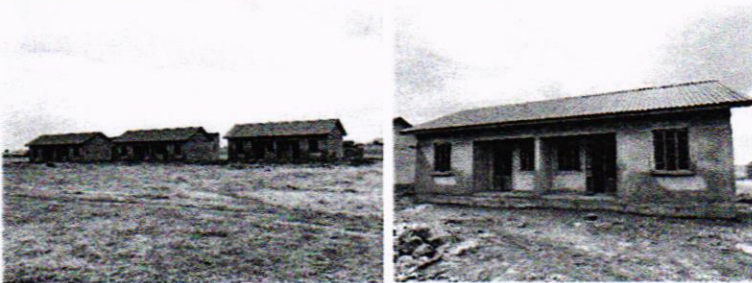
| Item | Pending works | Pictorial evidence |
|---|---|--|
| <p data-bbox="233 1458 418 1567"><b>Three 2-Unit Teachers House</b></p> | | <p data-bbox="776 1755 1539 1818"><i>No painting and no lightening arrestors on Three 2-Unit Teachers Houses One 2-Unit Teachers House</i></p> |

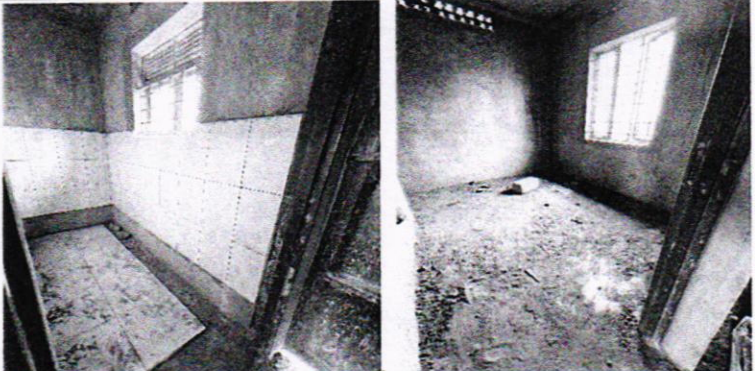
| Item | Pending works | Pictorial evidence |
|---|---|---|
| | | <p data-bbox="789 621 1549 728"><i>Bathroom pending floor and wall finishes and inside the staff house with incomplete floor and wall finishes</i></p> |

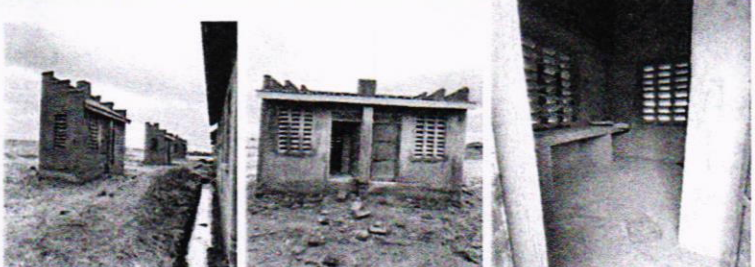
| Item | Pending works | Pictorial evidence |
|---|---|---|
| <p data-bbox="253 734 435 841"><b>Three 2-Unit Teachers Kitchen</b></p> | | <p data-bbox="789 1009 1549 1038"><i>Painting not done on Three 2-Unit Teachers Kitchen</i></p> |

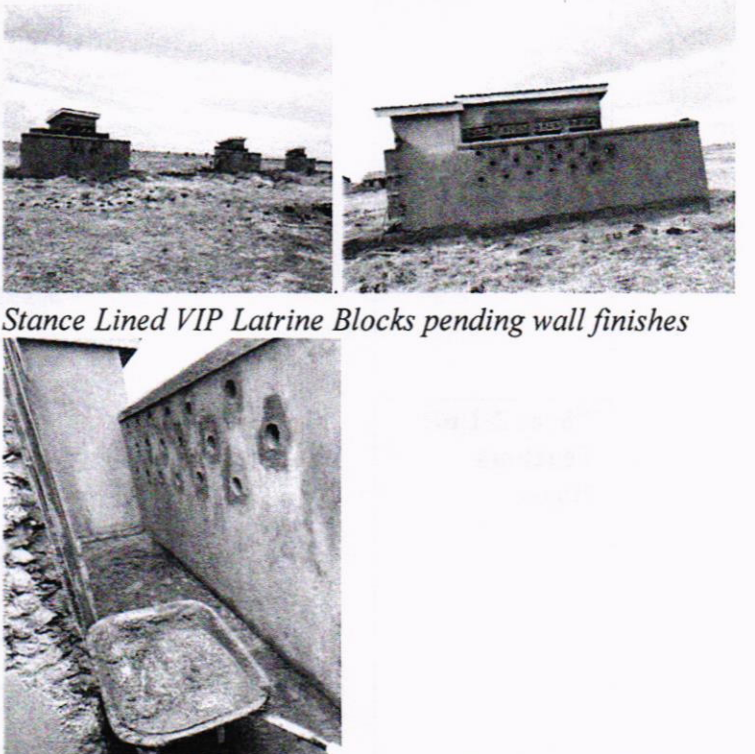
| Item | Pending works | Pictorial evidence |
|---|---|---|
| <p data-bbox="253 1045 435 1152"><b>Stance Lined VIP Latrine Blocks</b></p> | | <p data-bbox="789 1356 1549 1392"><i>Stance Lined VIP Latrine Blocks pending wall finishes</i></p> <p data-bbox="789 1816 1549 1848"><i>Slow works on VIP latrine, pending floor and wall finishes</i></p> |

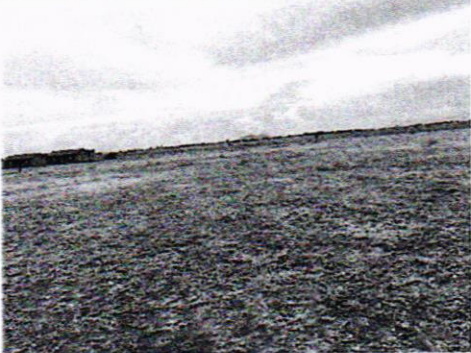
| Item | Pending works | Pictorial evidence |
|---|--|---|
| <b>One sports field</b> | <b>Slow progress of works</b><br>Grass planting and levelling of sports field not yet done | <p data-bbox="762 801 1345 835"><i>Sports field not levelled and grass not planted</i></p> |
