**CONTRACT AUDIT REPORT INTO THE CONSTRUCTION OF ALEKA SEED  
SECONDARY SCHOOL IN ALEKA SUB COUNTY, OYAM DISTRICT LOCAL  
GOVERNMENT UNDER THE UGIFT PROGRAM**

**CONTRACTOR: BUILDMAST ENGINEERING LIMITED**

**PROCUREMENT REF: MOES-UGIFT/WRKS/2022-2023/00001**

**JUNE 2025**

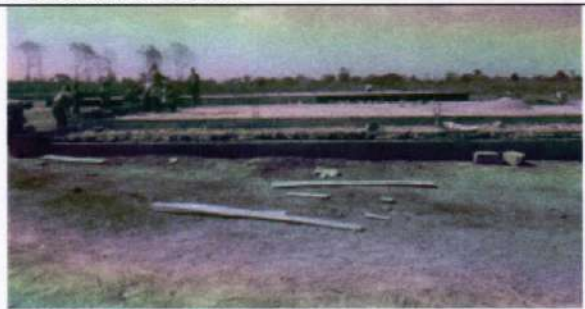
No.	Item	Status	Pictorial evidence
1.	Preliminaries costed at UGX 64,900,000	Not completed

<p>No site hoarding done (Images taken on 21<sup>st</sup> February 2025)</p>

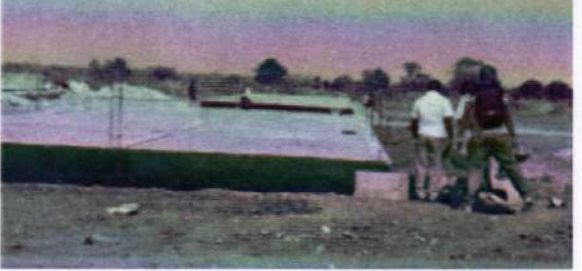
No.	Item	Status	Pictorial evidence
2.	2-Classroom costed at 583,701,000	Block UGX

<p data-bbox="850 506 1434 577">The buildings were at the foundational level (Images taken on 21<sup>st</sup> February 2025)</p>
3.	2-Unit Laboratory costed at 415,904,275	Science Block UGX

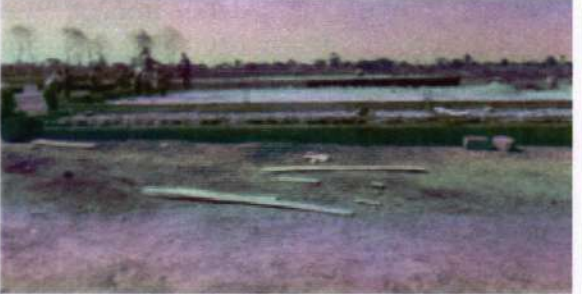
<p data-bbox="850 875 1434 947">The buildings were at foundational level (Images taken on 21<sup>st</sup> February 2025)</p>
4.	Administration costed at 231,345,600	Block UGX

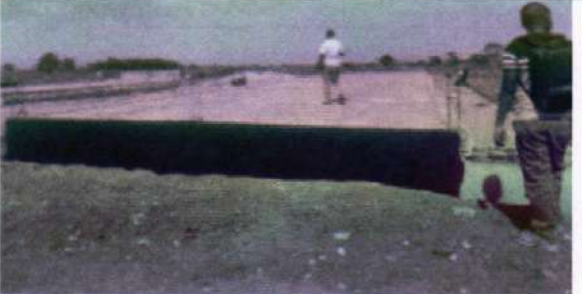
<p data-bbox="850 1245 1434 1317">The building was at foundational level (Images taken on 21<sup>st</sup> February 2025)</p>
5.	ICT-Library costed at 493,738,050	Block UGX

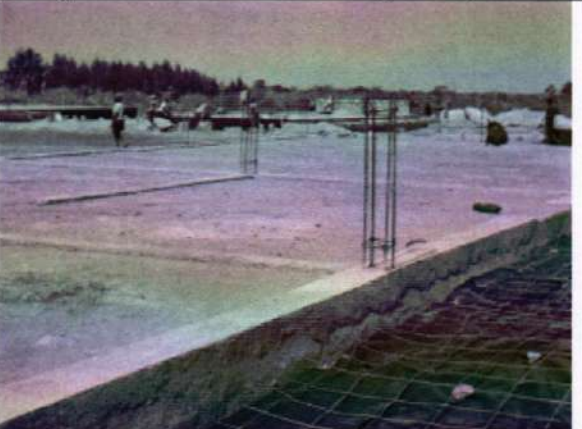
<p data-bbox="850 1749 1434 1823">The building was at foundational level (Images taken on 21<sup>st</sup> February 2025)</p>

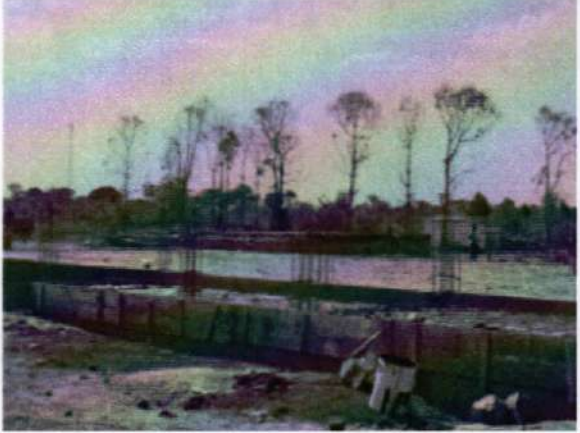
No.	Item	Status	Pictorial evidence
6.	Multi-Purpose Hall costed at UGX 534,371,050	Substructure level

<p>The building was at foundational level <i>(Images taken on 21<sup>st</sup> February 2025)</i></p>
7.	2-Unit Teachers House costed at UGX 385,186,800	Hardcore level

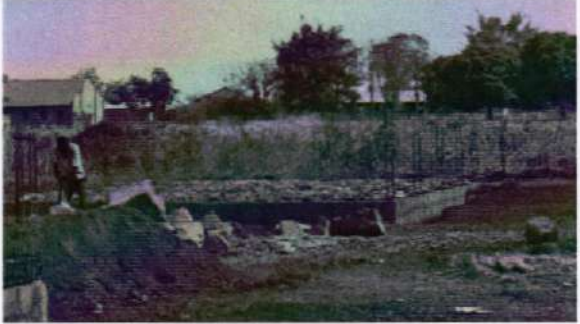
<p>Hardcore being compacted <i>(Images taken on 21<sup>st</sup> February 2025)</i></p>
8.	2-Unit Teachers Kitchen costed at UGX 97,640,000	Hardcore level

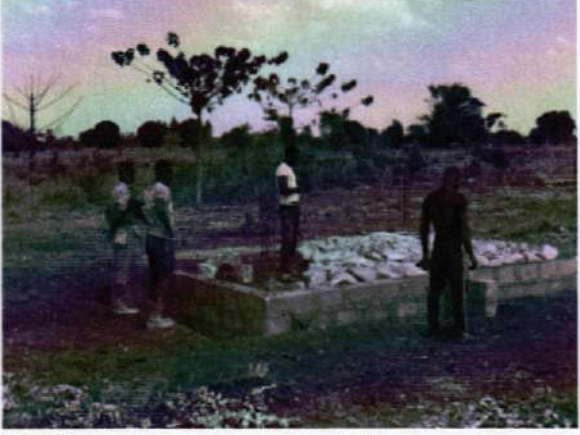
<p>Hardcore being compacted <i>(Images taken on 21<sup>st</sup> February 2025)</i></p>
9.	5-Stance Lined VIP Latrine Block-Boys costed at UGX 45,157,200

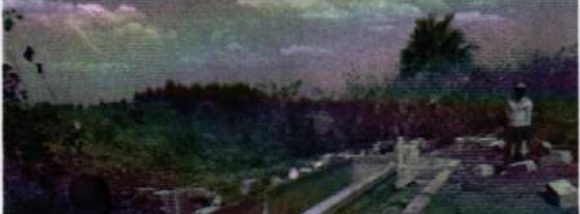
10.	5-Stance Lined VIP Latrine Block-Girls

No.	Item	Status	Pictorial evidence
	costed at UGX 45,157,200		Pits structure (Images taken on 21 <sup>st</sup> February 2025)
11.	2-Stance Lined VIP Latrine for Administration Block costed at UGX 22,490,000		
12.	External Works costed at UGX 89,155,000	Not started	
13.	Rain Water Harvest System With 5000l Water Tank costed at UGX 7,228,000	Not started	
14.	Sports field costed at UGX 50,000,000	Not started

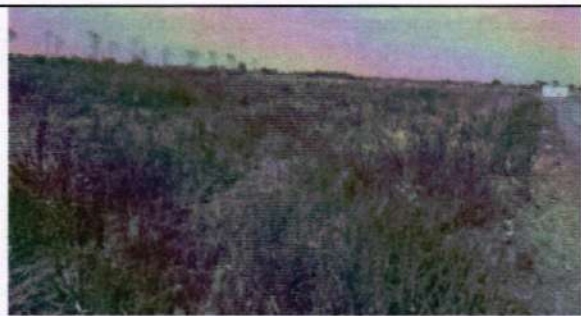
<p>Works not yet started (Images taken on 21<sup>st</sup> February 2025)</p>

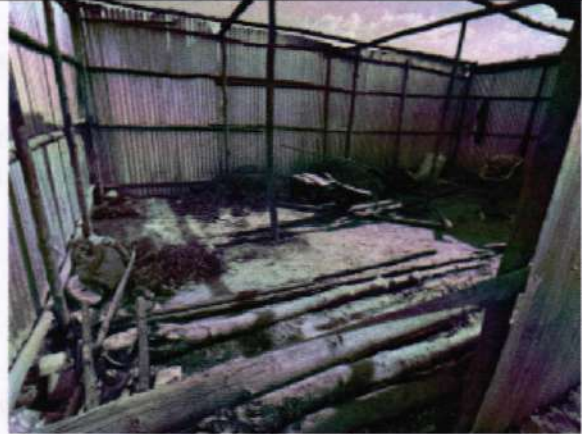
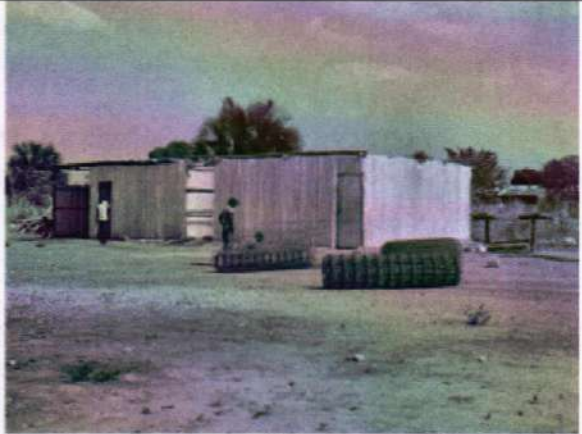
**Table 6: Poor storage of construction materials**

The Authority found that the contractor did not properly store all construction materials. The temporary store that was constructed at the site had no roof. During the physical verification, the team found some construction materials such as BRC mesh left outside and exposed to the effects of weather conditions, including very extreme heat and heavy rains as well as theft and tampering with materials, as detailed in Table 6 below:

Storage room without roof	Construction materials exposed to harsh weather conditions i.e., BRC Mesh

The Project Manager should task the contractor to undertake repairs on the stores for the construction materials in such a manner that upholds the quality of the materials.

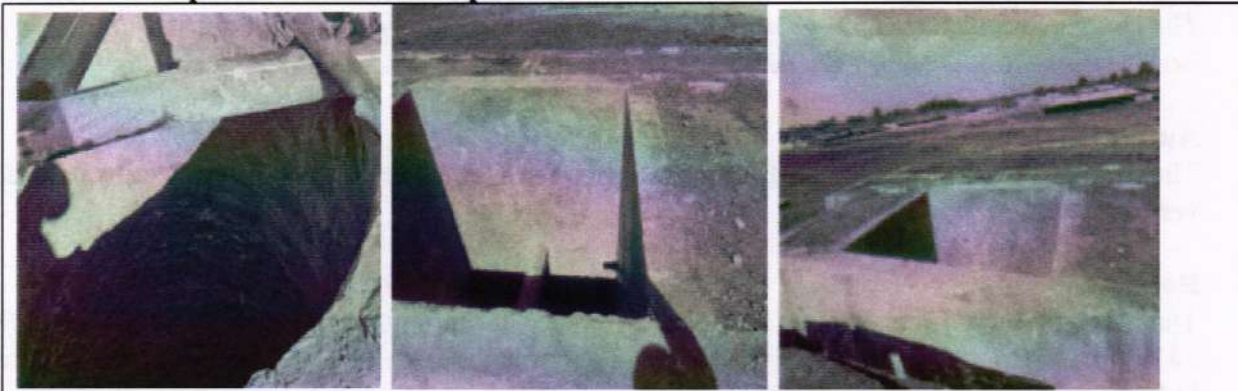
**Table 7:: Unprotected excavated pits**

The Authority found that the exposed excavated pits on site that had not been temporarily covered with logs, taped and labeled with warning signs posing safety risks to the site occupants and any persons that may wander into the site. Furthermore, the contractor did not install safety signs such as hazardous signs and caution signs including assembly point as shown in Table 7 below:

<p>Exposed excavated pit (<i>Images taken on 21<sup>st</sup> February 2025</i>)</p>

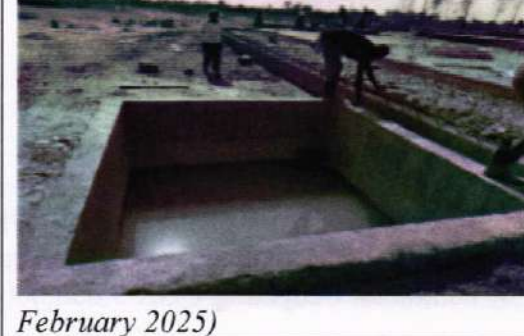
<p>Exposed water collection point (<i>Images taken on 21<sup>st</sup> February 2025</i>)</p>

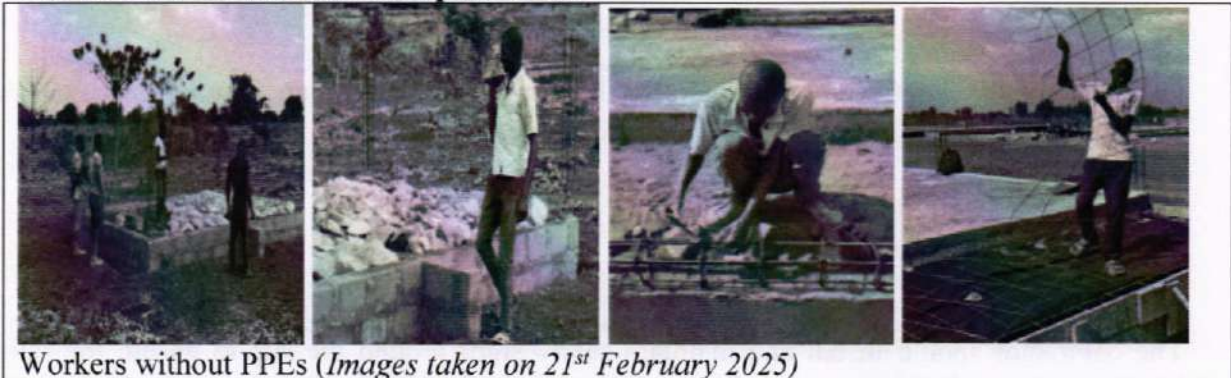
**Table 9: Workers without adequate PPEs**

- a) There was no comprehensive record of project workers with details showing their names, gender, age or place of origin. Furthermore, there were no consistent records of daily attendance of workers presence on the site.
- b) The workers did not have adequate personal protective equipment. Notably, all of the workers lacked helmets, gloves, gumboots, face masks and ear plug as shown in Table 9 below:

Workers without PPEs (Images taken on 21<sup>st</sup> February 2025)

The Project Manager, through the District Labour Officer, should ensure that the contractor, going forward addresses the labour issues raised to better the conditions of workers and subsequently increase productivity.

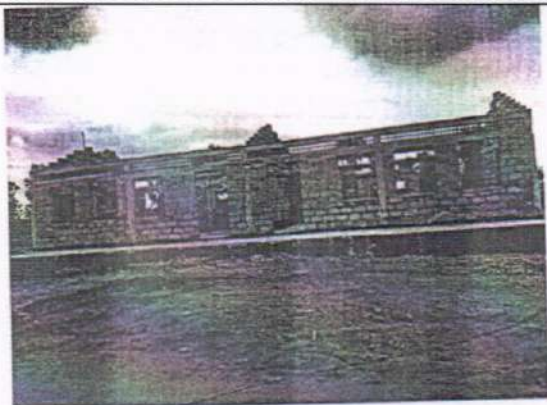
*Figure 4: Shows the laying of air bricks for ventilations in two classroom blocks.*

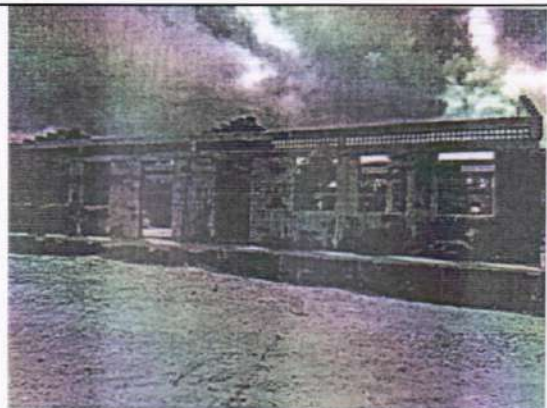
*Figure 6: shows the plastering done for two classroom block in the ratio of 1:3.*
