**CONTRACT AUDIT INTO THE COMPLETION OF CONSTRUCTION WORKS AT
KOLOLO SEED SECONDARY SCHOOL UNDER UGIFT PROGRAM**

**CONTRACTOR: ROBICH ENGINEERING SERVICES LIMITED, P.O. BOX 85,
KYAMBOGO.**

MAY 2026

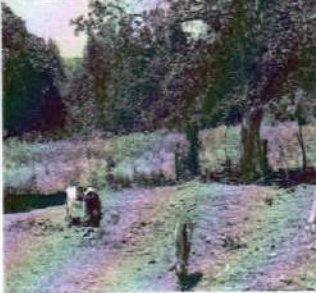
<p>Site was not cleared of construction material debris, unlevelled compound and used by the community as a grazing ground.</p>

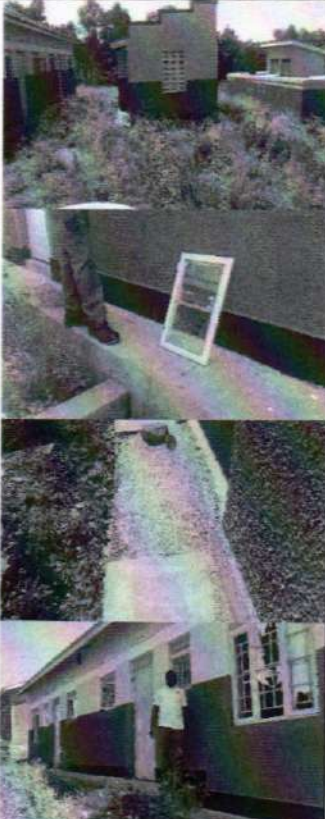
1.	2 blocks of 2-Unit teachers house.	<p>Work was incomplete and the pending works were:</p> <ul style="list-style-type: none"> • Floor finishes. • Joinery fittings. • Electrical installations.

<p>The Teacher's houses were unoccupied, abandoned and open to community access due to lack of a fence and gate to control movement in and around the staff house. The other shortcomings were;</p> <ul style="list-style-type: none"> • Incomplete behind walk-in steps in the 1st block. • Uninstalled water harvesting tanks and gutters. • Lack of glasses and frames, in some windows. • Broken, cracked and smashed door glasses.

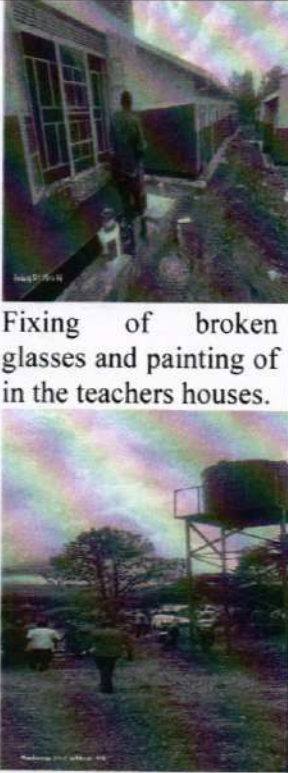
<p>Fixing of broken glasses and painting of in the teachers houses.</p> <p>Water tanks at Teachers houses.</p>

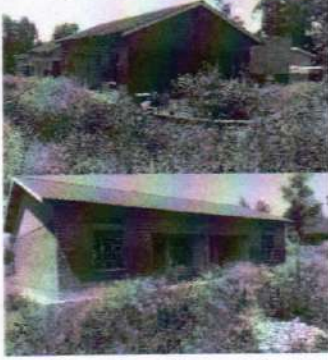
2.	External works.	Planting of grass and general site levelling had started. The pending works was due to pending completion of structural works.

<ul style="list-style-type: none"> • Site levelling of the staff house compound; not done. • Trees and paspalum grass; not planted. • Building materials debris on site; not cleared.

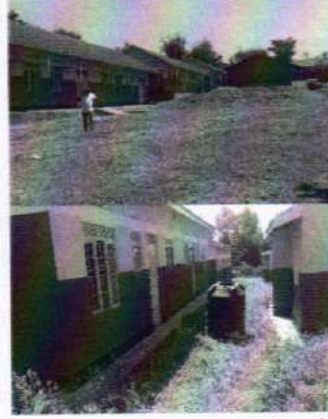
3.	Rain water harvest system with 5000ml water tank.	No work done.

<p>No gutters and 5000ml water tanks installed around the classrooms and staff house.</p>

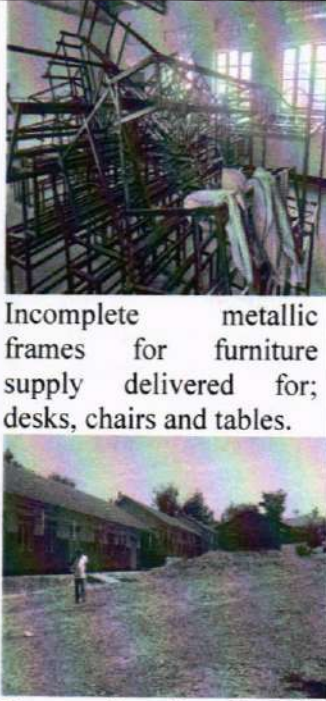
4.	Multi-purpose hall and classroom.	<p>Work was incomplete and the pending works were:</p> <ul style="list-style-type: none"> • Supply and fixing inbuilt shelves. • Supply and fixing open shelves. • Supply and fixing of soft pin boards. • Fabrication of stools and assembling. • Teachers table fabrication and assembling. • Teachers chairs with hard sheets.

<p>Incomplete metallic frames for furniture supply delivered for; desks, chairs and tables.</p> <p>No soft pin boards installed in the classrooms.</p>	<p>A contract with a new contractor already signed and contractor is already mobilising to complete the remaining furnitures, fixtures and fittings.</p>

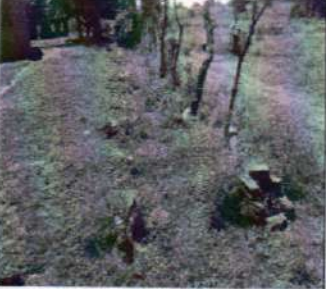
5.	Sports field.	<p>No work was done. An extension of land was required to accommodate the required dimensions of the sports field. Engagements had started with the church leadership to relocate the nearby cemetery to pave way for the required dimension.</p>

<p>The sports field right adjacent to the school fence in the above picture was done, except for bush clearance.</p>

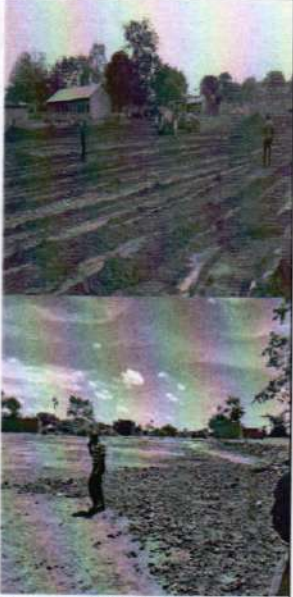
<p>Sports field left with grass planting and goal posts which are already welded.</p>

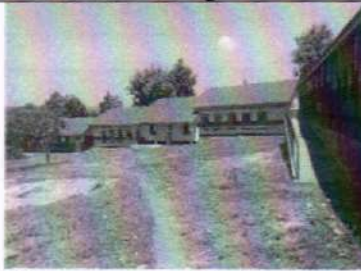
Findings	Site visit photos to support the audit findings	Management response / current status
<p>General overview of Kololo Seed School site.</p>

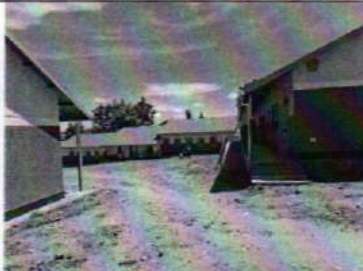
<p>Classroom block and multipurpose hall</p>

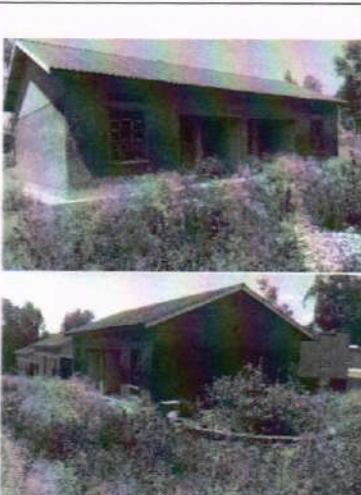
<p>Compound levelling work done around the school.</p>
<p>Incomplete works in the school;</p> <ul style="list-style-type: none"> • The water tank base in the staff house. • The first block in the staff house was not painted.

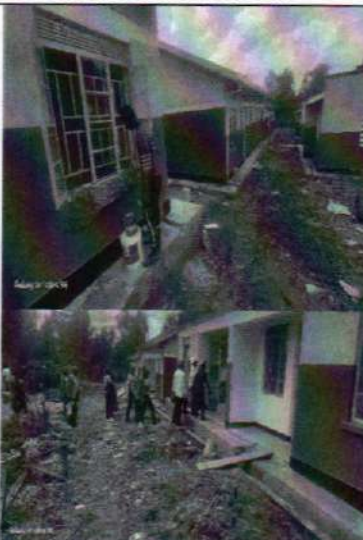
<p>Incomplete structures at Kololo Seed Secondary School.</p>

<p>Current state of works in the staff house.</p>

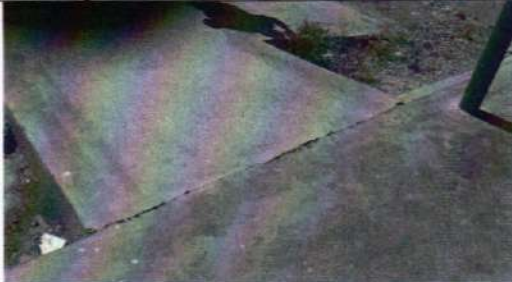
Table 6: Cracks in the ramps to the classrooms

Regulations 52 (1) (b) of the PPDA (Contracts) Regulations, 2023 states that; *“A Contract Manager shall — make certain that the provider performs the contract in accordance with the terms and conditions specified in the contract”*. The Authority observed cracks in the ramps to the classrooms, which exhibited potential low-quality output. The forementioned was also an indicator of inadequate supervision of the construction works by the Project Manager to ensure that the contractor implemented the project to the desired quality standards. This further negates the technical capacity of the contractor. Photos of the same are presented in Table 6 below.

No.	Project milestone	Audit findings.	Site visit photos to support the audit findings.
1.	3 blocks of 2-Classroom block.	Cracks in the ramps to the classrooms.

<p data-bbox="970 1514 1484 1574">Cracked bonding between the ramp and veranda to the classrooms.</p>

Cracks in the ramps to the classrooms, exhibited potential low-quality workmanship and this exposes the facility to short use life span and need for repair works in a short period of use, thereby increasing the project cost.

A new contractor has been procured and minor repairs and corrections have been factored in the scope of works.

1. Task the contractor to repair the cracks in accordance with the technical specifications of the contract, costs in the BoQs, and the terms and conditions of the contract. In implementing the forementioned, the Project Manager should be guided by the requirements under Regulations 52 (1) (b) of the PPDA (Contracts) Regulations, 2023.
