**PUBLIC PROCUREMENT AND DISPOSAL  
OF PUBLIC ASSETS AUTHORITY**  
*"Regulating for Results"*

**CONTRACT AUDIT INTO THE UPGRADE OF ALANGO  
HEALTH CENTRE II TO HEALTH CENTRE III IN OTUKE  
DISTRICT (Contractor: WML Consult & Engineering Ltd.)**

**OTUKE DISTRICT LOCAL GOVERNMENT**

**MARCH 2026**

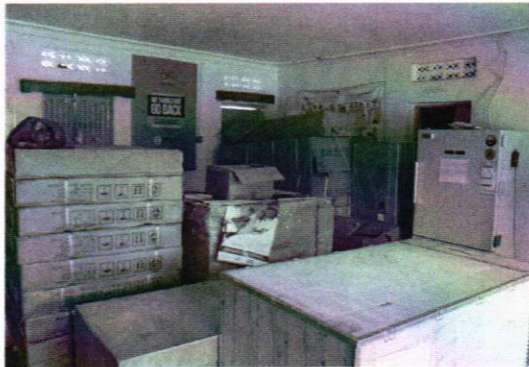
*Crates of equipment stacked in the OPD*

*Equipment in the OPD building*

The medical equipment worth UGX. 224,784,434 (Appendix III) that was procured separately and supplied by another provider, CEM Enterprises (U) Ltd., remained uninstalled and unverified due to the incomplete health facility works. The crates/boxes were stored within the active Outpatient Department (OPD), Consultancy Room, and Store, effectively encroaching on clinical space. This hindered the delivery of ongoing healthcare services, compromised patient flow, and created an unsafe environment for both staff and patients within the existing facility.

2. The District Health Officer to:
  - i) Conduct a joint technical verification exercise with CEM Enterprises (U) Ltd. and the District Internal Auditor to assess the physical condition, completeness, and warranty status of all delivered equipment. The resulting report must confirm that no damage occurred during the period of improper storage and clearly define liability for any defects identified before the equipment is commissioned.

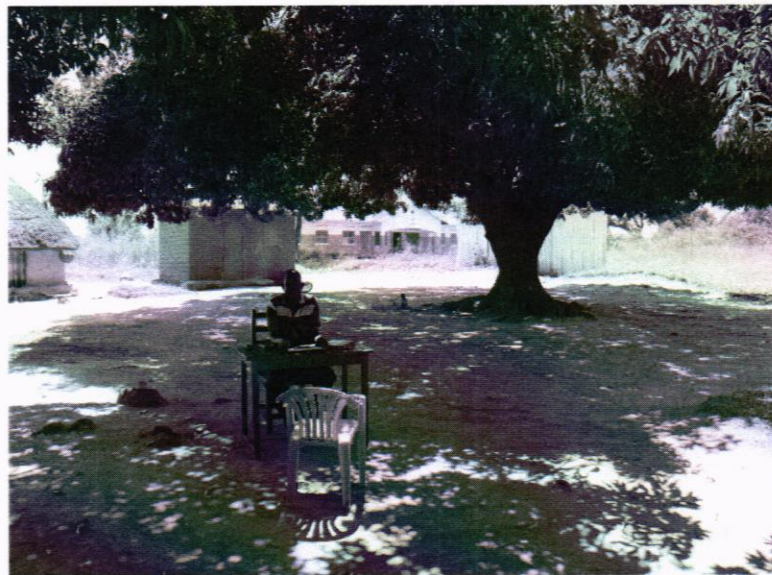
*Hospital Incharge operating under a tree*

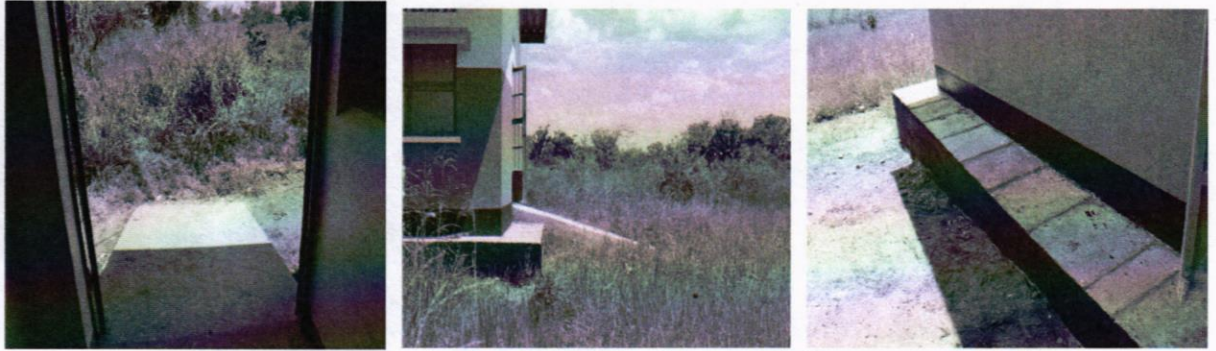
**MATERNITY WARD**

- **Protection:** Windows lacked weather canopies, exposing the interior to harsh weather. The splash apron (intended to protect the foundation) had cracks and was poorly cast.

*Inaccessible ramp, bushy site and poorly cast splash apron respectively*

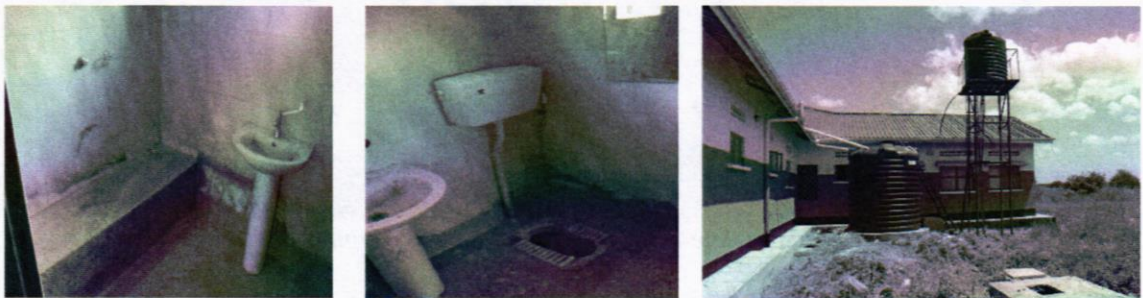
- **Sanitary Fittings:** All internal toilet accessories including shower heads, toilet roll holders, soap dishes, and Special Needs (PWDs) hinged support grabrails were missing.

*Missing toilet accessories including shower heads, toilet roll holders, soap dishes, PWDs hinged support grabrails; and incomplete water system including missing manholes, gully traps, soak pits, and septic tanks, respectively.*

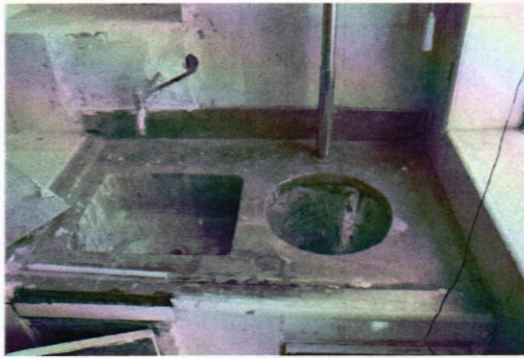
- **Incomplete Fixtures:** Lighting fixtures were incomplete. Only six out of seven required pinboards were installed and these exhibited severe brown staining and moisture damage, indicating the use of poor-quality materials.

*Poor finishes, incomplete sinks and one of the pinboard with brown staining, respectively.*

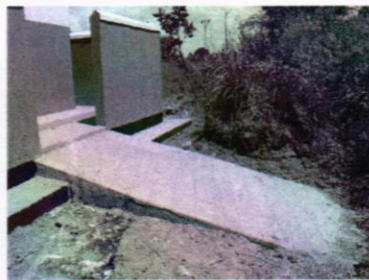
**VIP 4 STANCE + SHOWER**

- **Failure of PWDs Inclusivity:** Despite the BoQs requirements, there were no armrests or grab rails.
  - **Ramp Inaccessibility:** The ramps were not leveled with the floor slabs and terminated into unpaved, uneven soil. In addition, the female wing ramp's proximity to the Placenta Pit created a physical bottleneck that prevents the necessary turning radius for wheelchair users.

*Inaccessible ramps to both the Female and Male toilets respectively*

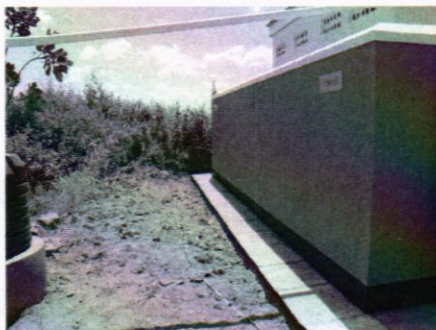
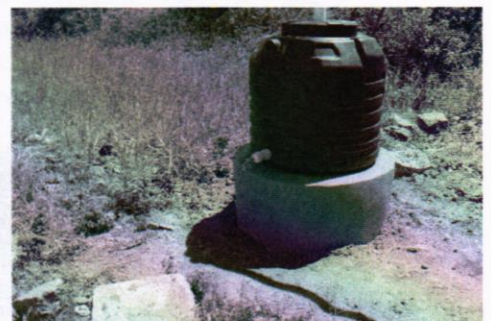
- iii) **4 Stance VIP Latrine + Shower (Male and Female)**
- **Drainage Malpractice:** The 500-liter overhead tank lacked a soak pit, causing wastewater to discharge directly onto the ground. This leads to soil erosion and stagnant water hazards.

*Unpaved, uneven soil and bushy site obstructing access to the Male toilet, missing armrests or grab rails; and 500-liter overhead tank without a soak pit, respectively*

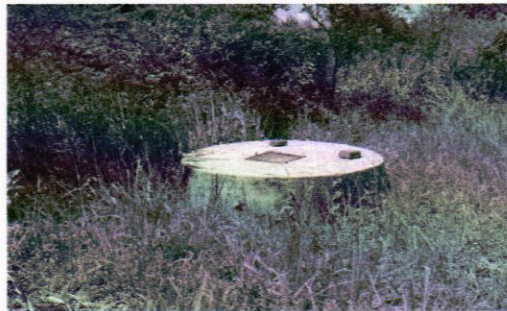
**MEDICAL WASTE PIT**

- iv) **Medical Waste Pit**  
The cover was rusted and failed to seal properly, which is a significant biosafety risk.

*Medical waste pit with a rusted cover and surrounded by a bush*

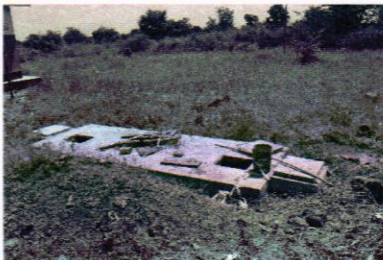
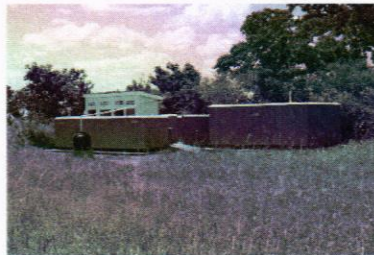
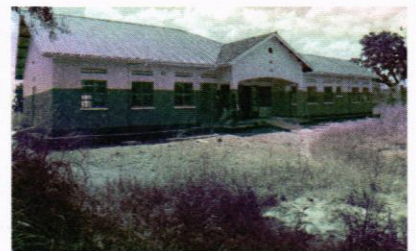
**EXTERNAL WORKS/ LANDSCAPING**

- iii) **Physical Hazards:** The site was unfenced (not hoarded), unlit, unguarded and overgrown with a bush. In addition, there was a total absence of safety signage, warning tapes around dangerous spots like the open septic tank and broken glass found on site.

*Absence of safety signage, warning tapes around dangerous spots like the open septic tank and broken glass, and the site was unfenced (not hoarded), unlit, unguarded and overgrown with a bush.*
