**CONTRACT AUDIT REPORT FOR THE CONSTRUCTION OF ARINGO MONE  
SOLAR POWERED IRRIGARION SYSTEM IN LATANY SUB-COUNTY, PADER  
DISTRICT**

**IMPLEMENTED BY: MINISTRY OF WATER AND ENVIRONMENT UNDER  
FORCE ACCOUNT**

**JULY 2026**

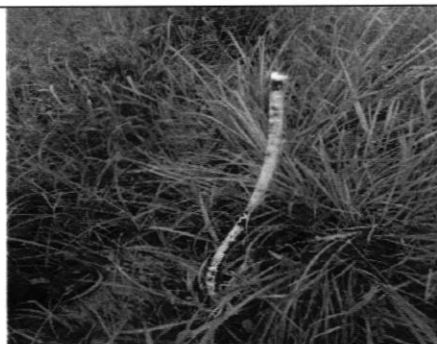
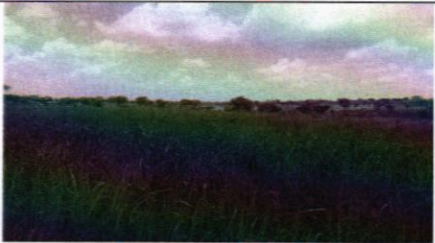
| Component | Description | Progress as per the Final Progress report of March 2020 | Authority's Observation |
|---|---|---|---|
| Irrigation System | <ul style="list-style-type: none"> <li>• Main Pipe- PVC PN10,110M M.</li> <li>• Sub main- PVC PN6, 90mm.</li> <li>• Laterals- PVC PN6,63mm.</li> </ul> | 100% | |

| Component | Description | Progress as per the Final Progress report of March 2020 | Authority's Observation |
|---|---|---|---|
| | <ul style="list-style-type: none"> <li>• ¾" brass sprinklers on 3/3 PVC riser pipes.</li> <li>• Accessories (Dends, Tees, Valves).</li> </ul> | | <p>Only one damaged sprinkler with no control valve was seen, the rest were vandalised and removed from the site.</p> |

1. The Accounting Officer should:
  - a) Obtain proof of land ownership (title or legal documentation) where the project is located to avoid conflict that may affect the success of such projects.
  - b) Allocate resources to repair or replace damaged components to revive the irrigation system.

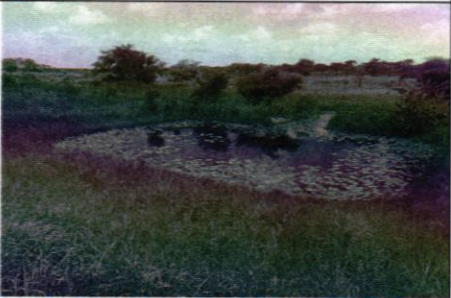
| Component | Description | Progress as per the Final Progress report of March 2020 | Authority's Observation |
|---|---|---|---|
| Water intake structure | Excavation of a sump on form of a valley tank (2,000m <sup>3</sup> capacity) to store part of the water diverted from River Larumo. | 100% | <p>Non maintained and abandoned valley tank.</p> |

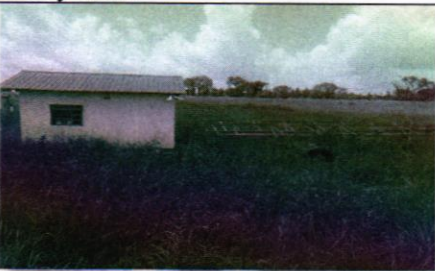
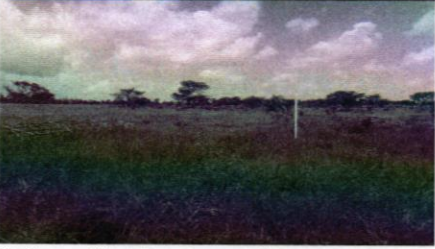
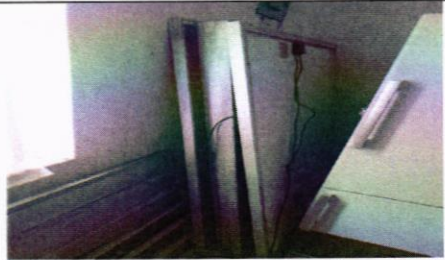
During the physical verification of the project, the Ministry team informed the Authority that the project got burnt by a wildfire that damaged most of the project components such as submersible pump with hybrid inverter, transmission main to the reservoir, pump station, reservoirs and an on-farm irrigation system, solar panels steel nursery bed structure and fence.

| Component | Description | Progress as per the Final Progress report of March 2020 | Authority's Observation |
|---|---|---|---|
| Solar System | <ul style="list-style-type: none"> <li>• 40 pieces of 275 Watts each in an array on steel mounting structure.</li> <li>• Submersible water pump of 30m<sup>3</sup>/hr discharge and head of 60m installed within the sump.</li> </ul> | 100% | <p>Solar Steel mounting structure without solar panels.</p> |

| Component | Description | Progress as per the Final Progress report of March 2020 | Authority's Observation |
|---|---|---|---|
| | | | <p>Out of the 40 solar panels installed, the Authority verified only 16 panels stored at Latany Health Centre. 24 solar panels were missing. The Entity stated that 2 two panels were damaged by wild fire and 22 were at Ministry of Water equipment yard.</p> |

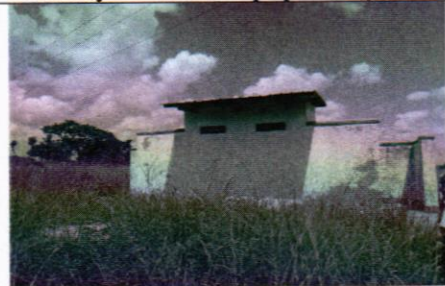
| Component | Description | Progress as per the Final Progress report of March 2020 | Authority's Observation |
|---|---|---|---|
| Sanitation facility | Two stance lined VIP latrine with two bathrooms and hand-washing facility (For male and female) | 100% | <p>Incomplete VIP latrine.<br/>Incomplete painting. Painting was stopped at undercoat.<br/>No drawings for VIP latrine.<br/>Not Engraved to indicate female or male section.</p> |

- i) Failure to provide for a section for PWDs on VIP latrine.
  - ii) Un engraved two lined VIP latrine.
  - iii) Uncovered manholes.
  - iv) There were no safety signs such as warning tapes on uncovered pits.
- This was due to inadequate involvement of Environment Officers during project implementation.

The Authority noted the Entity's response, however noted that one of the major target groups (beneficiaries) for the project was persons with disabilities (PWDs) yet the VIP latrine did not have handrail to support the PWDs.

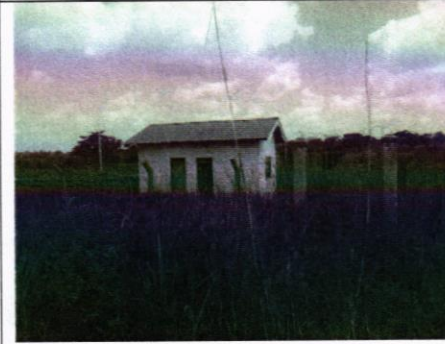
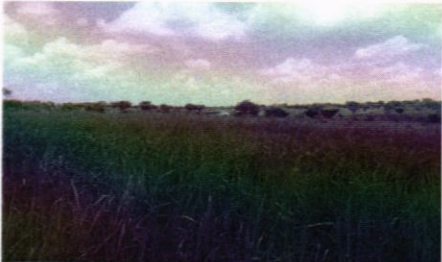
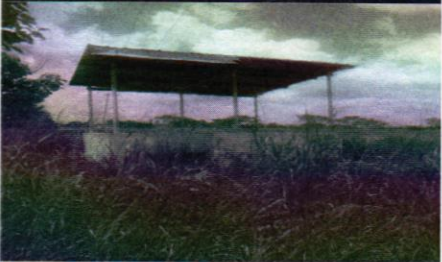
| Component | Description | Progress as per the Final Progress report of March 2020 | Authority's Observation |
|---|---|---|---|
| Fencing | <ul style="list-style-type: none"> <li>Barbed wire mounted on treated gum poles for the entire farm.</li> <li>Chain-link mounted on concrete poles for the water</li> </ul> | 100% | |

| Component | Description | Progress as per the Final Progress report of March 2020 | Authority's Observation |
|---|---|---|---|
| | abstraction area. | | <p>Damaged chain link fence on pump house.</p> <p>No barbed wire mounted on treated gum poles for the entire farm</p> |

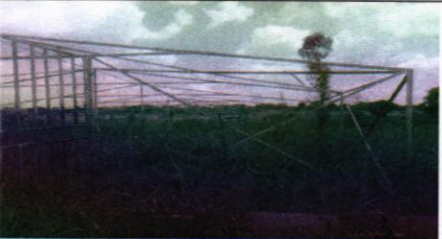
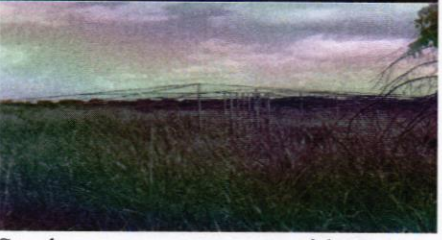
| Component | Description | Progress as per the Final Progress report of March 2020 | Authority's Observation |
|---|---|---|---|
| Nursery bed | A steel nursery structure for raising of seedlings. | 95% | <p>Steel nursery structure with no top covering net.<br/>No nursery bed was seen.</p> |
