**PUBLIC PROCUREMENT AND DISPOSAL  
OF PUBLIC ASSETS AUTHORITY**

**REPORT ON CONTRACT AUDIT FOR THE REHABILITATION OF 13.40  
KM COMMUNITY ACCESS ROAD ALONG TIRA-SALAMA/MAKUYA-  
NDEGE-ANGOLLOLO-BUSABI-AKORET, BUSIA DISTRICT**

**ENTITY: BUSIA DISTRICT LOCAL GOVERNMENT**

**SEPTEMBER 2026**

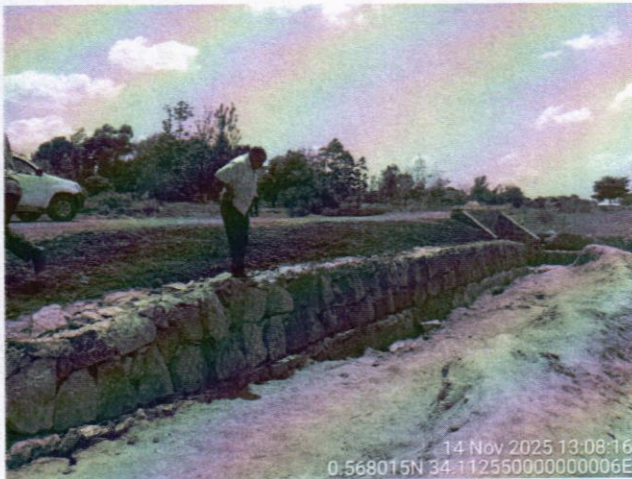
However, the Authority was concerned that the local communities were engaged on road side sand and gold mining which was affecting the roads embankments and drainage. The Authority was also concerned with the miners use of mercury to *wash-off* the deposits of gold mining along the roads drainage, flowing off into the streams, which is likely the contaminate water used by humans and animals.

| <p><i>Good quality murram finishing on Makuya- Ndege-Angollolo-Busabi road</i></p> | <p><i>The gabion protection embankment against erosion effect resulting from Sand mining along the drainage/road reserve on</i></p> |

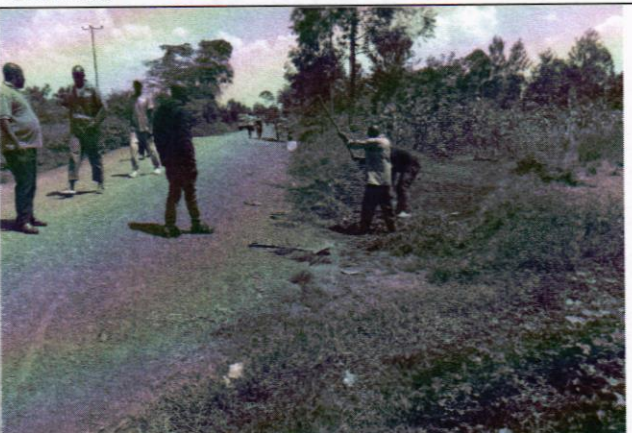
The absence of the contractor on site most likely led to the failure to complete the work on time. The absence was also likely to lead to deterioration of completed sections as evidenced by silting in different sections on the project site.

| <p><i>A protected 1200mm bridge on Manakori-Akoret Road near the Sand mining spot</i></p> | <p><i>Manual maintenance of the Completed Road section. Desilting of Side/miter drains, Culverts and water Channels</i></p> |

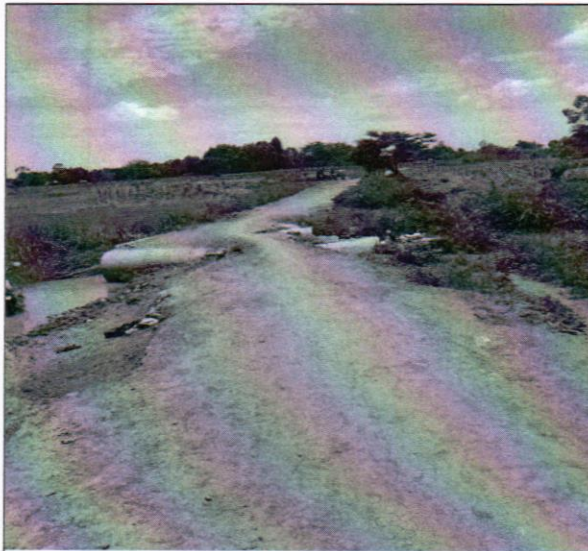
| <p><i>The impassable damaged section of One of the selected CARs under the Batch B yet to be tendered Road (Butebi-</i></p> | <p><i>The impassable damaged section of One of the selected CARs under the Batch B has been restored under Routine road maintenance program (Butebi-Kateki-Kayolo SS road) pending design at section</i></p> |

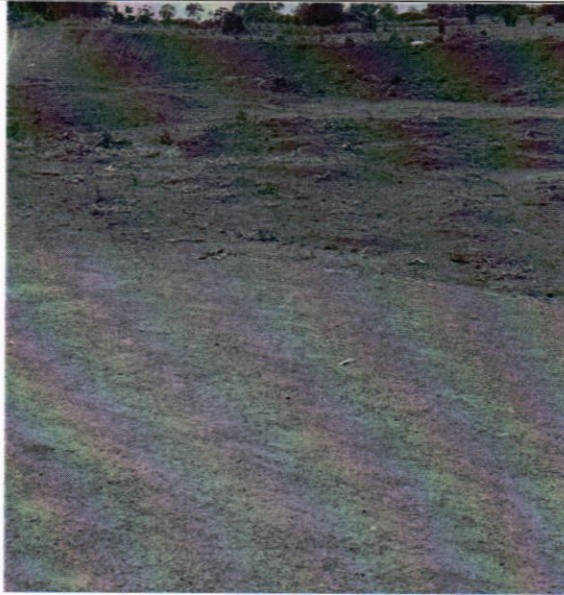
*Manakori-Akoret Road drainage wash-away may compromises longevity of the Road and expected to be rectified during DLP*

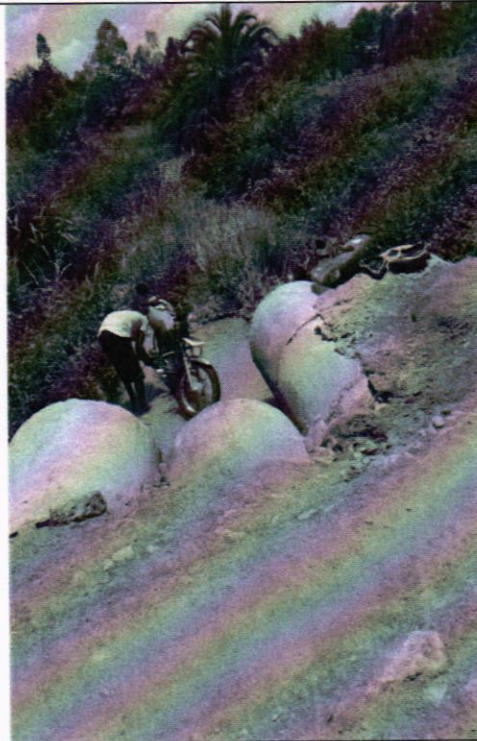
*impassable damaged section of yet to be tendered Road (Butebi-Kateki-Kayolo SS Road) under Batch B*
