**PUBLIC PROCUREMENT AND DISPOSAL  
OF PUBLIC ASSETS AUTHORITY**

**CONTRACT AUDIT INTO THE COMPLETION OF  
CONSTRUCTION OF OKUM SEED SECONDARY SCHOOL  
IN OTUKE DISTRICT (CONTRACTOR: WANGI GENERAL  
ENTERPRISES (U) LTD)**

**OTUKE DISTRICT LOCAL GOVERNMENT**

**APRIL 2026**

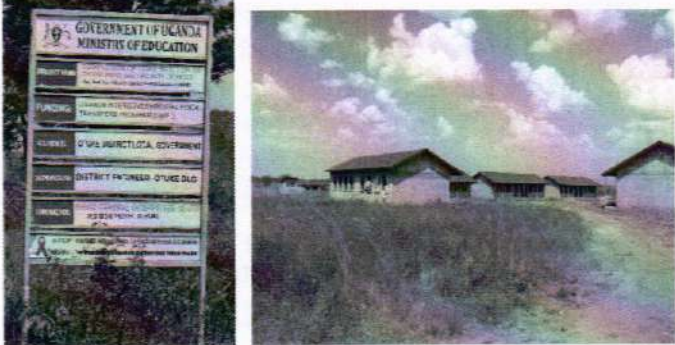
<p><i>Installed project signboard; unhoarded site</i></p>
Site Levelling Works	Clearance of bushes, shrubs, under growth, cutting down trees not exceeding 1500mm girth, including grubbing roots and removing these away from site.

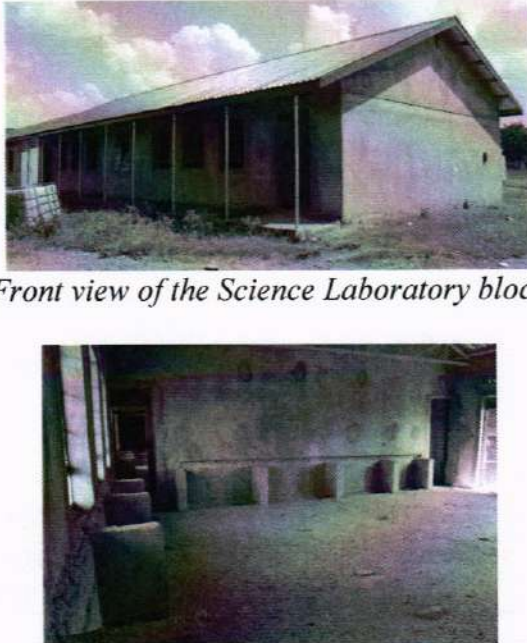
<p><i>Front view of the Science Laboratory block</i></p>

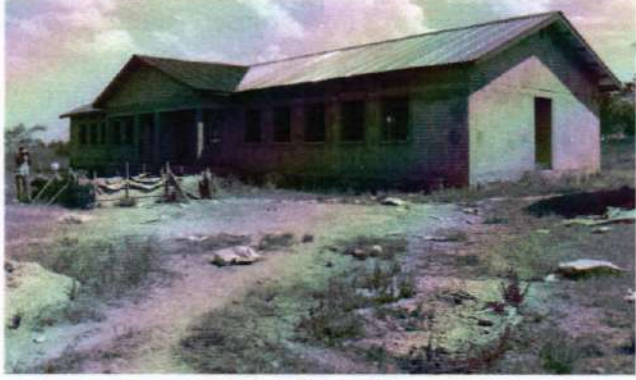
<p style="text-align: center;"><i>Front view of ICT Library block</i></p>

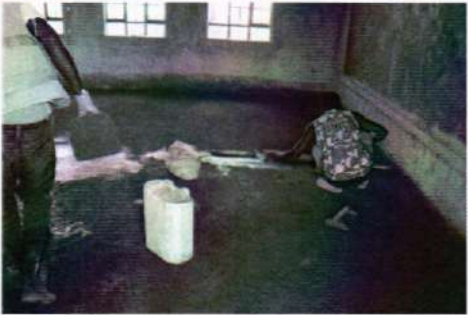
<p style="text-align: center;"><i>Workers doing floor screeding</i></p>

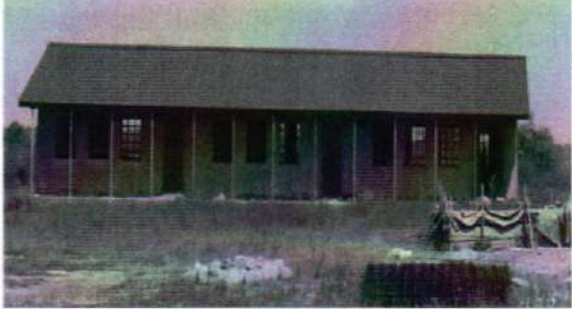
<p style="text-align: center;"><i>Front view of Multi-Purpose Hall</i></p>

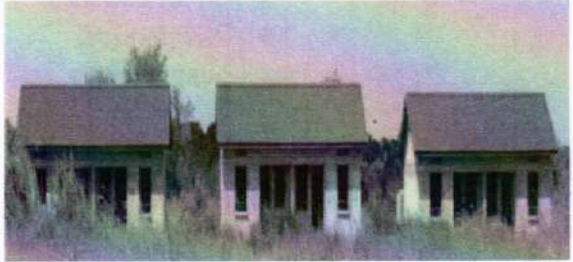
<p style="text-align: center;"><i>Teachers' houses</i></p>

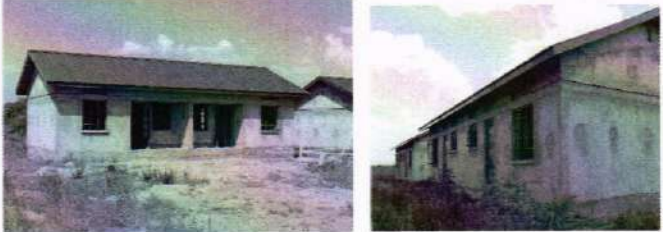
<p style="text-align: center;"><i>Ongoing works</i></p>
2-Unit Teachers' Kitchen (3No.)	<p>The three kitchens were at superstructure level.</p> <p>Pending works included:</p> <ul style="list-style-type: none"> <li>• Walling</li> <li>• Roofing and rainwater disposal</li> <li>• Doors</li> <li>• Wall finishes</li> <li>• Floor finishes</li> <li>• Ceiling finishes</li> <li>• Joinery fittings</li> <li>• Electrical installations</li> <li>• Mechanical installations</li> </ul>

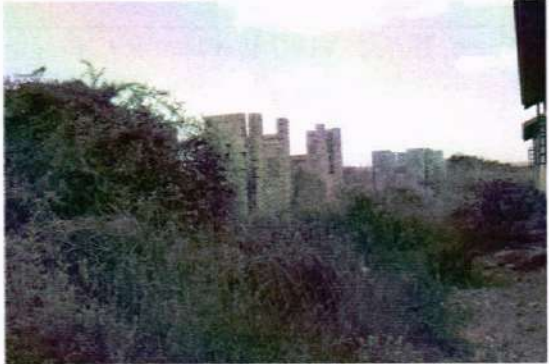
<p style="text-align: center;"><i>Two of the kitchens in a bushy area</i></p>

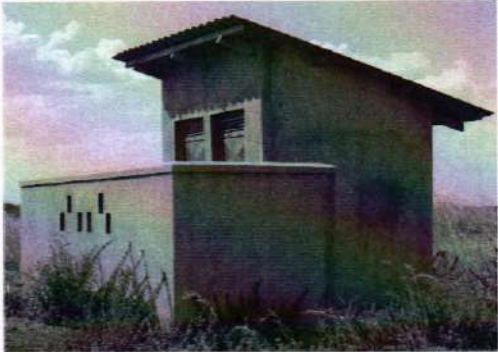
<p style="text-align: center;"><i>2-Stance Lined VIP Latrine</i></p>
2-Stance Lined VIP Latrine Block for Teachers' Houses (3 No.)	<p>Pending works included:</p> <ul style="list-style-type: none"> <li>• Walling</li> <li>• Roof and rainwater disposal</li> <li>• Doors</li> <li>• Wall finishes</li> </ul>

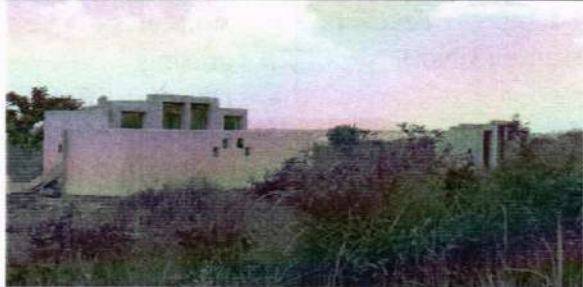
<p data-bbox="954 528 1385 562"><i>Two of the toilets in a bushy area</i></p>
5-Stance Lined VIP Latrine Block – Boys	<p>It was at R.C Frame.</p> <p>Pending works included:</p> <ul style="list-style-type: none"> <li>• Rainwater disposal</li> <li>• Doors- repainting</li> <li>• Wall finishes</li> <li>• Floor finishes</li> <li>• Mechanical installations</li> </ul>

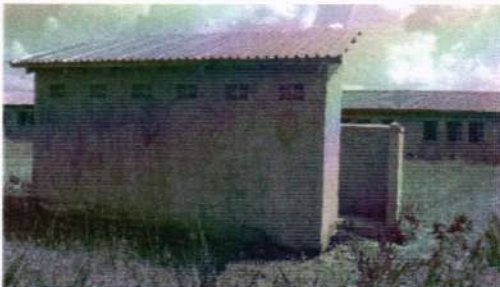
<p data-bbox="943 873 1390 907"><i>5-stance lined VIP latrine for boys</i></p>
5-Stance Lined VIP Latrine Block - Girls	<p>It was at R.C Frame.</p> <p>Pending works included:</p> <ul style="list-style-type: none"> <li>• Rainwater disposal</li> <li>• Doors- repainting</li> <li>• Wall finishes</li> <li>• Floor finishes</li> <li>• Mechanical installations</li> </ul>

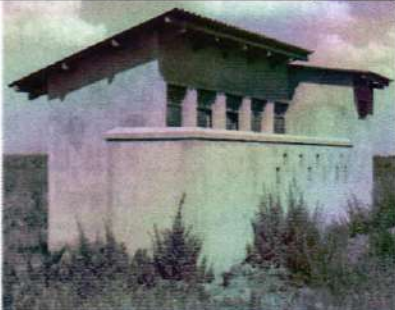
<p data-bbox="943 1223 1390 1256"><i>5-stance lined VIP latrine for girls</i></p>

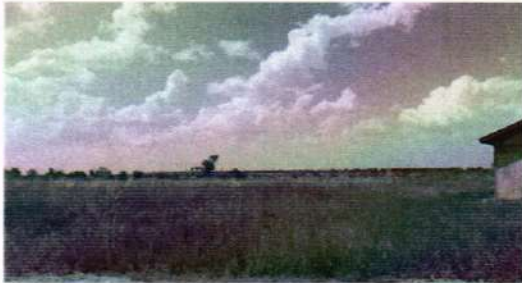
<p data-bbox="1086 1565 1243 1599"><i>Sports field</i></p>
External Works	<p>Not commenced.</p> <p>Pending works included:</p> <ul style="list-style-type: none"> <li>• Site clearance</li> <li>• Storm water drainage</li> <li>Landscaping</li> </ul>

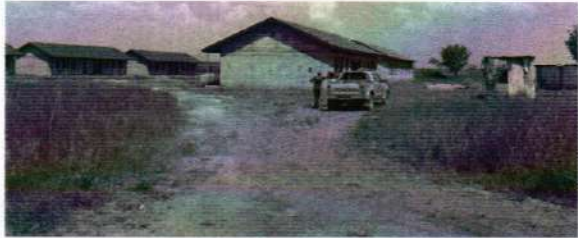
<p data-bbox="938 1863 1390 1897"><i>External works not yet commenced</i></p>
Rain Water Harvest System with 5000L Water Tank	<p>Not commenced</p> <p>Pending works include:</p> <ul style="list-style-type: none"> <li>• Roof water drainage</li> <li>• Protective walling</li> </ul>
