**CONTRACT AUDIT OF THE GIZ ESCALATED CASE INTO THE PARTIAL
CONSTRUCTION OF A STAFF HOUSE AT ONYWAKO HEALTH CENTER II IN
LIRA DISTRICT**

CONTRACTOR: BUILDMAST ENGINEERING LIMITED

PROCUREMENT REF: Lira880/WRKS/2023-2024/00004

APRIL 2026

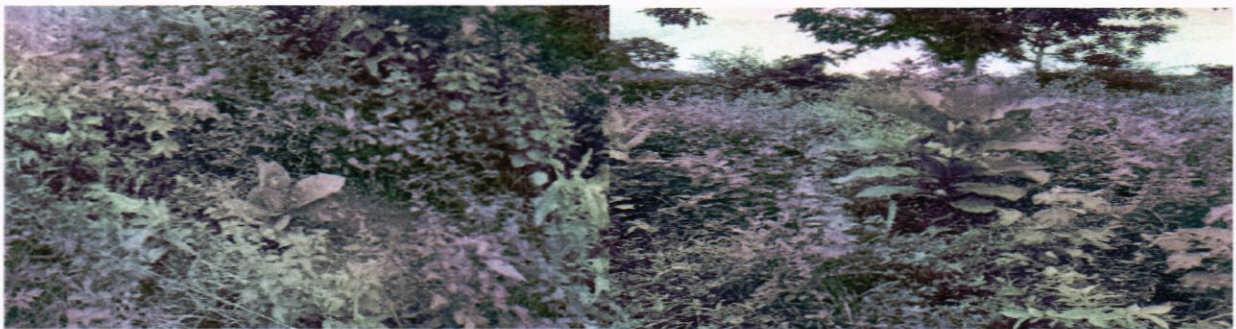
Section 66 of the PPDA Act, Cap. 205 mandates that Procuring and Disposing Entities take into account environmental protection, social inclusion, and the promotion of innovation in every procurement process. A review of this contract revealed that the contractor implemented environmental mitigation measures by planting trees around the project site; however, the trees are poorly maintained and are growing in a dense, bushy environment due to insufficient facilitation. See photographs below.

Trees planted were growing under difficulty in a bush and not well maintained for proper growth.

The Accounting Officer should task and instruct the Health Center II staff in-charge to take responsibility and ensure that the trees planted around the health center grow well by protecting them from damage by grazing animals and human, since they are growing in bushy environment.

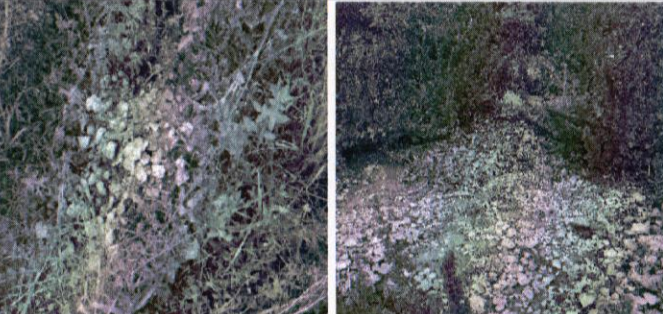
GCC 43 mandated the Project Manager to instruct the contractor to conduct sample tests to rectify any defects. The audit findings from the Supervising Engineer, however, revealed that at commencement of the site works, the contractor obtained low-quality concrete building blocks and casted a weak concrete floor slab in the building. The rejection of these blocks and substandard concrete floor slab by the Supervising Engineer in an instruction issued on 30th May 2024, resulted from a failure by the contractor to follow the proper technical engineering construction processes regarding mix proportion, handling, and treatment.

<p>Debris of hacked concrete floor slab that failed the quality test and was rejected by the Supervising Engineer.</p>

1. Hack off the casted concrete floor slab and re-do it. This affects the quality of work; and
2. Remove all the concrete building blocks that had been delivered on site and have the right quality of the concrete blocks for the super structure construction.

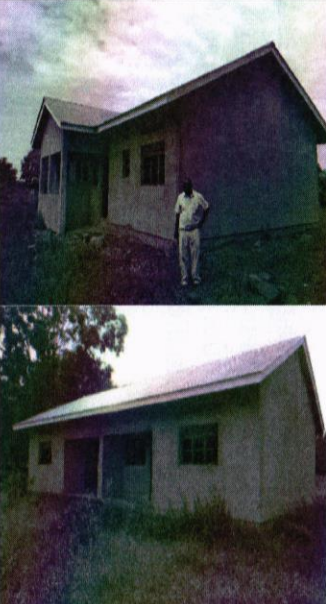
The Authority noted the Entity's response, however, during physical verification, the rejected concrete blocks was a safety hazard, potentially harboring snakes. Donating rejected materials does not absolve the contractor of their contractual obligation to leave the site in a "clean and tidy

<p>Part of the rejected building blocks on site and in the site store, that failed the quality test and was rejected by the Supervising Engineer.</p>

The Accounting Officer should direct the Contract Manager to ensure that the temporary storage structure left on site by the contractor is removed accordingly and the site is cleared of all the buildings materials and construction debris, to secure the site from the above risks.

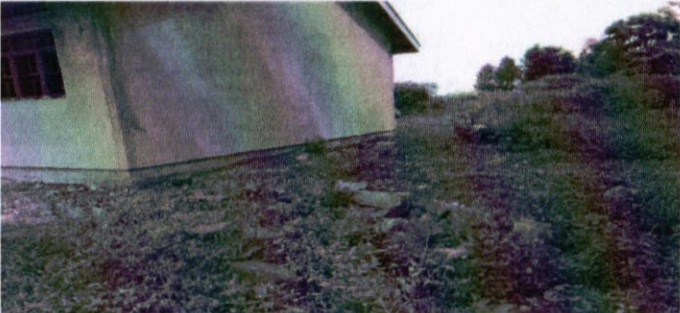
<p>Re-casted concrete floor slab below the superstructure.</p>

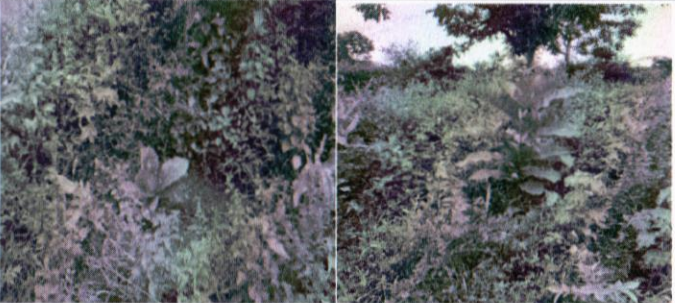
<p>Trees planted in the bush and not well managed for proper growth.</p>

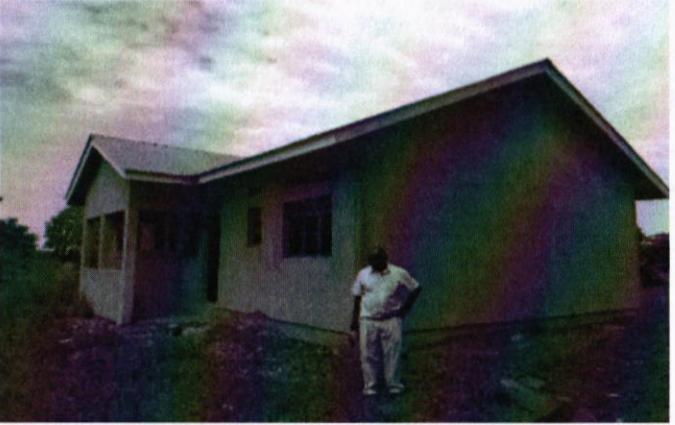
<p>The staff house partially completed</p>

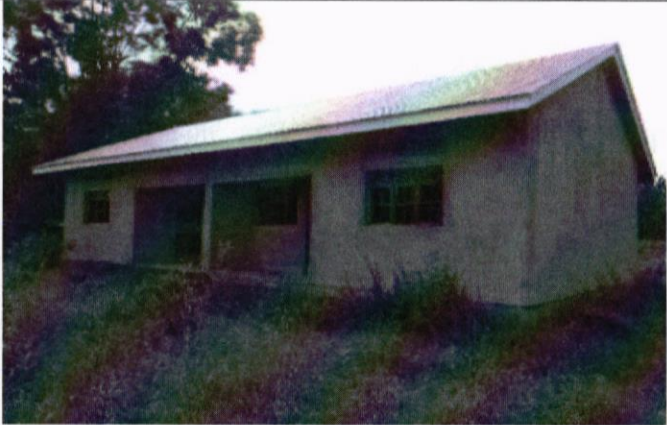
<p>Incomplete staff house in the Health Center.</p>

5. **Project Expansion and Security:** The District Health Officer should plan for the full completion of the staff house and the construction of additional wards and a chain-link fence to improve service delivery and site security.
