**CONTRACT AUDIT REPORT INTO THE CONSTRUCTION OF AMURU TOWN
COUNCIL SEED SECONDARY SCHOOL (CONTRACTOR: AGWERU GENERAL
MERCHANDISE LIMITED) AND AMURU SEED SECONDARY SCHOOL
(CONTRACTOR: DAVRICH COMPANY (U) LIMITED)**

AMURU DISTRICT LOCAL GOVERNMENT

MAY 2026

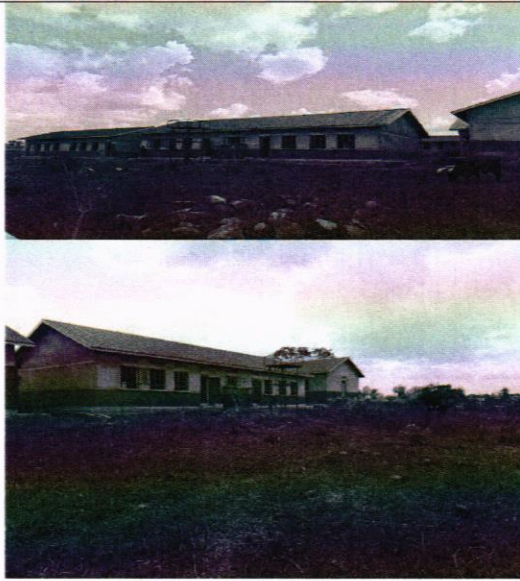
Item Description	Status of the works	Pictorial evidence
1 No. 2 unit Science Laboratory Block	Pending works; <ul style="list-style-type: none"> • External and Internal painting. • Glazing of windows and doors. • Laboratory sinks not connected with elbow tap and traps. • Wash hand basins - installed but with no taps and outlet connectors. • Electrical installations. • Blackboard painting. • Gutters and down pipes. • Glass windows.

The Project Manager should closely monitor the project implementation and supervise the performance/delivery obligations of the contractor, in accordance with the terms and conditions of the contract as required under Regulation 52 (3) (a) ((i) of the PPDA (Contracts) Regulations, 2023.

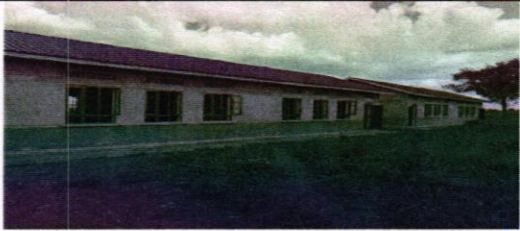
Item Description	Status of the works	Pictorial evidence
3 No. 2-Unit Classroom Blocks	Pending works: <ul style="list-style-type: none"> • External and Internal painting. • Glazing of windows and doors. • Earthing. • Blackboard painting. • Gutters and down pipes. • Book shelves shutters. • Painting of blackboards. • Bulbs. • Supply of desks.

<p><i>Behind view of classroom block</i></p>

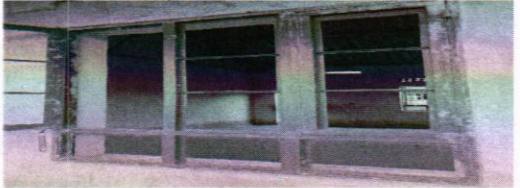
<p><i>Unglazed classroom windows</i></p>

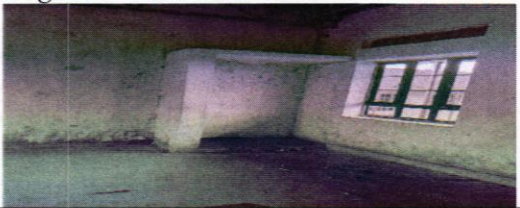
1 No. Administration block.	Pending works: <ul style="list-style-type: none"> • External and Internal painting. • Glazing of windows and doors. • Electrical installations. • Blackboard painting. • Gutters and down pipe. • Furniture. • Ceiling access cover. • Internal door frames and shutters.

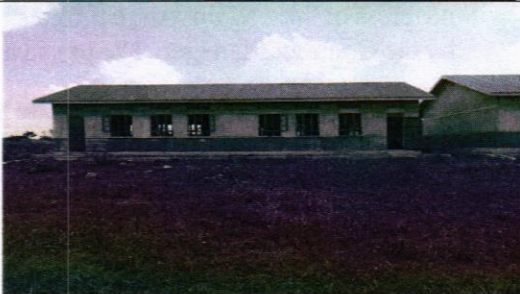
<p><i>Front view of the Administration block</i></p>
ICT /Library block	Pending works: <ul style="list-style-type: none"> • External and Internal painting. • Glazing of windows and doors. • Electrical installations. • Gutters and down pipes. • Furniture.

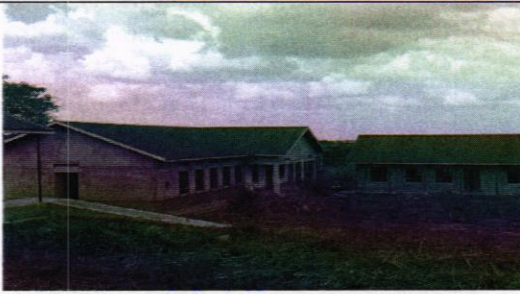
<p><i>Incomplete painting of the Library Block</i></p>

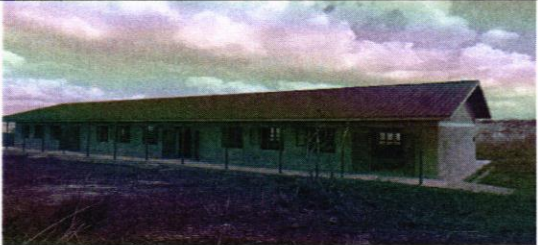
<p><i>Front view of the Multipurpose Hall</i></p>

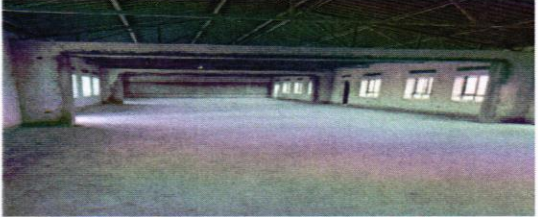
<p><i>Unpainted interior of multipurpose hall</i></p>
<p>3 No. 2-unit Staff houses.</p>	<p>Pending works:</p> <ul style="list-style-type: none"> • External and Internal painting. • Glazing of windows and doors. • Electrical installations. • Gutters and down pipes.

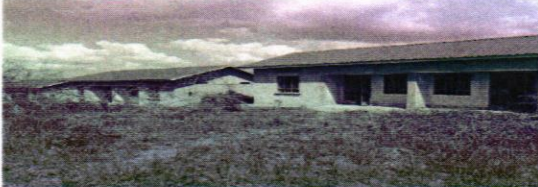
<p><i>Incomplete staff houses</i></p>

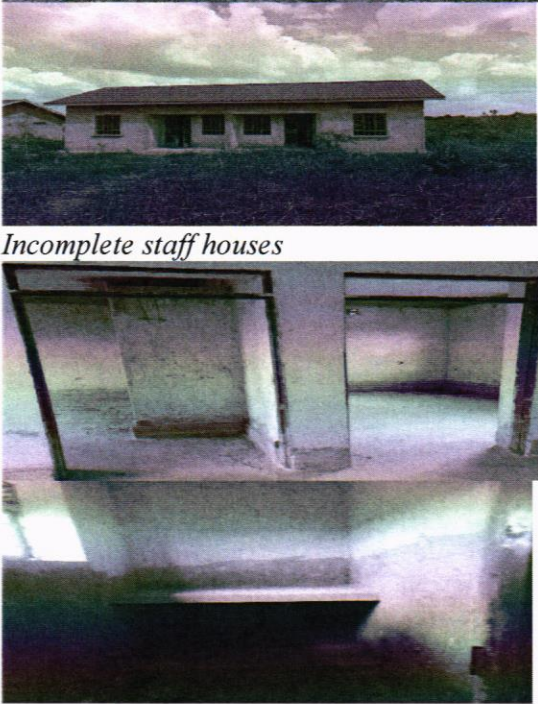
<p><i>Interior fittings not yet fixed</i></p>

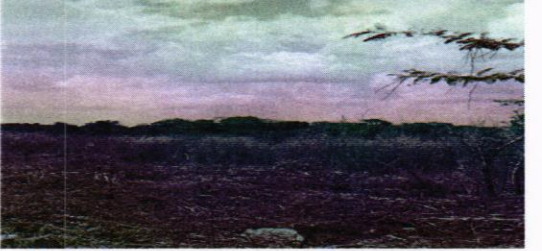
Sports field.	Pending work: <ul style="list-style-type: none"> • Leveling. • Grass planting.

<p data-bbox="882 1335 1158 1364"><i>Incomplete sports field</i></p>

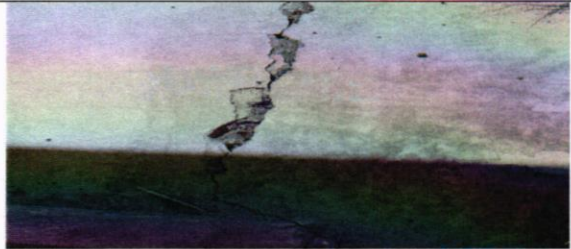
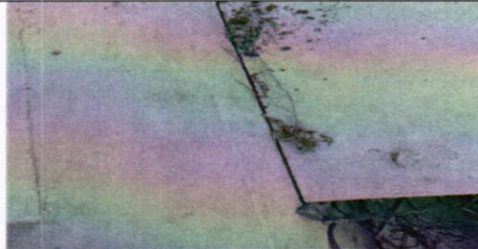
Multipurpose hall

<i>Poor quality of the floor screed</i>

1. The Project Manager should develop a complete snag list and instruct the contractor, Spider Contractors Limited, to correct all the defects identified above.
2. The Accounting Officer should task the Project Manager to ensure that the contractor meets all performance and delivery obligations as outlined in the terms and conditions of the contract, in accordance with Regulations 52 (3) (a) (i) of the PPDA (Contracts) Regulations, 2023.

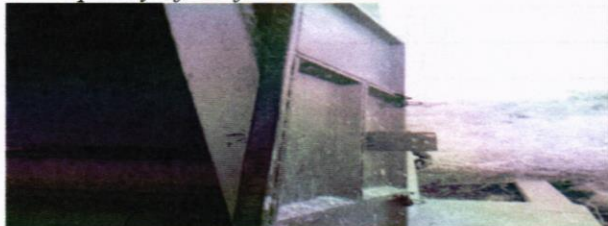
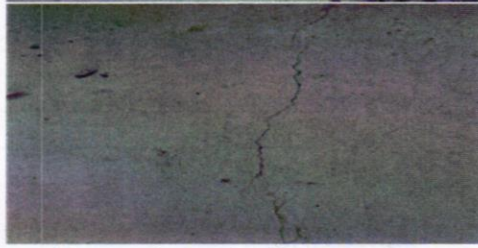
<i>Poorly fitted door</i>	<i>Visible cracks on the floor</i>
Staff houses

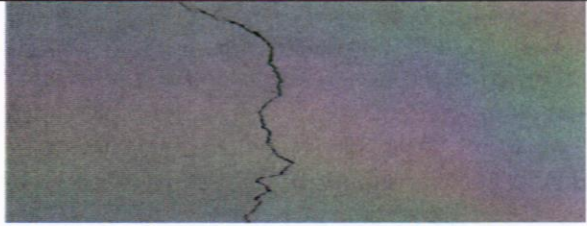
<i>Cracked ceiling</i>

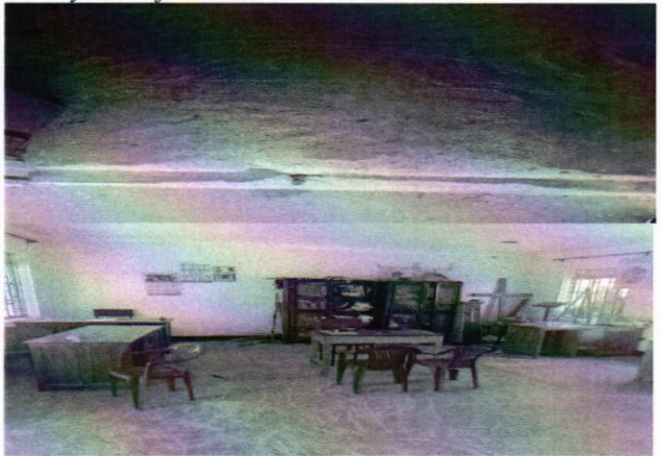
<p><i>Staff room already in use</i></p>

1. The Accounting Officer should instruct the Project Manager to value and prepare BoQs of the pending works and tender the pending works to achieve successful completion of the project before the end of FY 2025/2026.
2. The Project Manager should develop a complete snag list and instruct the contractor, Davrich Company (U) Limited, to correct all the defects identified above.

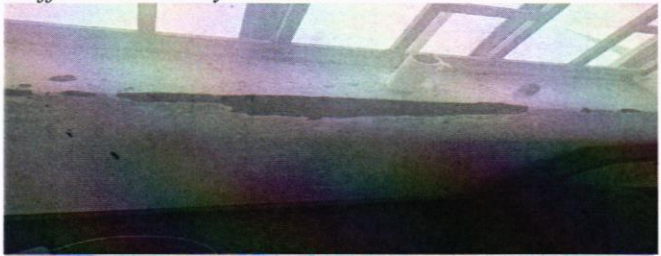
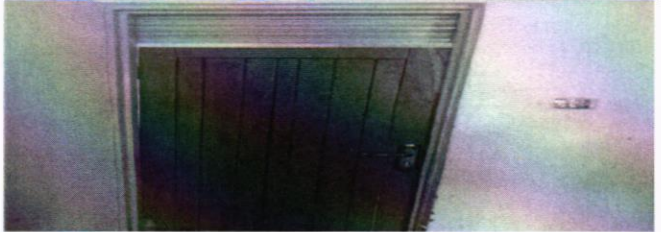
<p><i>Poor quality doors</i></p>
<p>2-Unit Science Laboratory Block</p>	<p>Pending works;</p> <ul style="list-style-type: none"> • Laboratory sinks not yet installed. • Wash hand basins- not

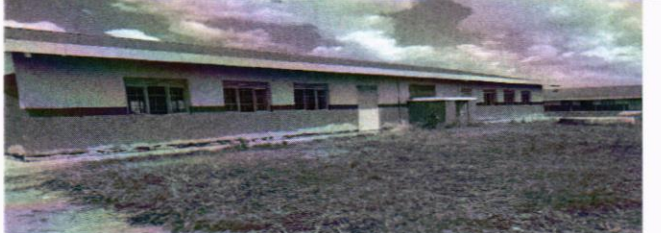
Item Description	Status of the works	Pictorial evidence
	<p>yet installed.</p> <ul style="list-style-type: none"> • Painting. • Floor finishes. • Window glasses. • Incomplete electric installations • Incomplete plumbing works. • Incomplete worktops. • Chalk board. • Water tanks. • Interior doors. • Glasses in the windows. • Downspout pipe. • Furniture. • Shelves. <p>Observations</p> <ul style="list-style-type: none"> • Poorly done floor screed (internal and external). • Poor quality of painting. <p>Pending works;</p> <ul style="list-style-type: none"> • Glasses in the windows. • Furniture. • Downspout pipe. • Water tanks. • Chalkboard rails.

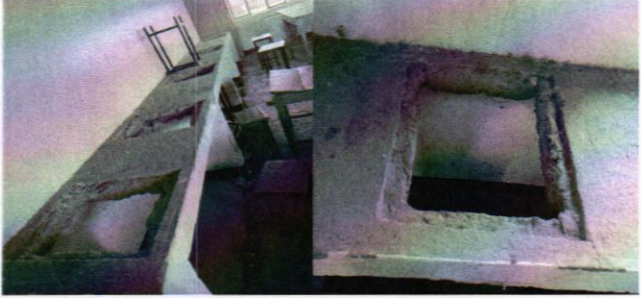
<p><i>Incomplete worktops in the science lab</i></p>

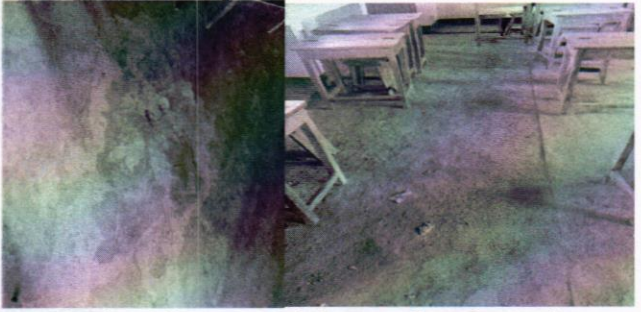
<p><i>Poorly done floor screed that needs to be re-done</i></p>

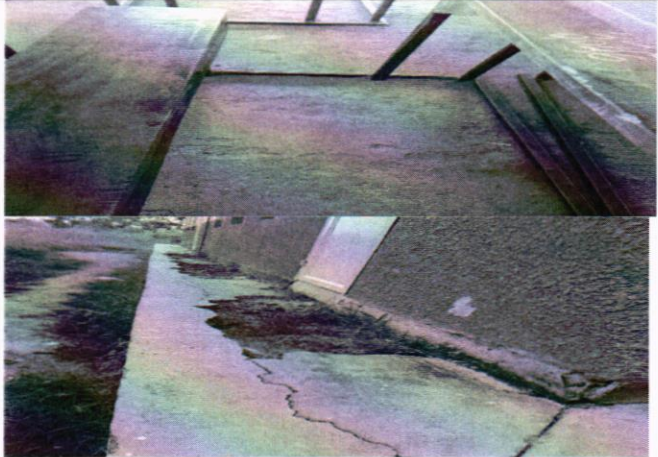
Item Description	Status of the works	Pictorial evidence
Classroom Blocks	<ul style="list-style-type: none"> • Observations • Collapsing veranda. • Shutters on teacher's shelves. • Poorly done floor screed (internal and external). • Poor quality of painting. • Leaking roofs.

<p data-bbox="746 712 1407 750"><i>Shoddy works on the veranda</i></p>

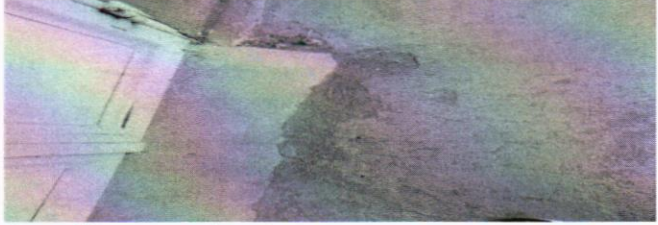
<p data-bbox="746 974 1407 996"><i>Poor floor screed at the entrance</i></p>
5-Stance Lined Vip Latrine Block	<p data-bbox="470 996 734 1041">Pending works:</p> <ul style="list-style-type: none"> • Manhole covers. • PWD handle. • Not engraved. <p data-bbox="470 1254 734 1288">Observations</p> <ul style="list-style-type: none"> • Collapsing veranda on boys toilet. • Poor painting.

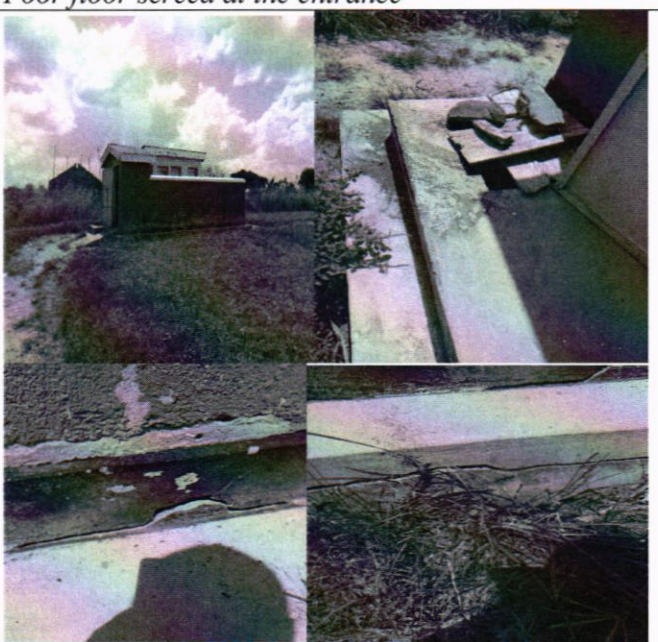
<p data-bbox="746 1635 1407 1668"><i>Cracked toilet foundation</i></p>

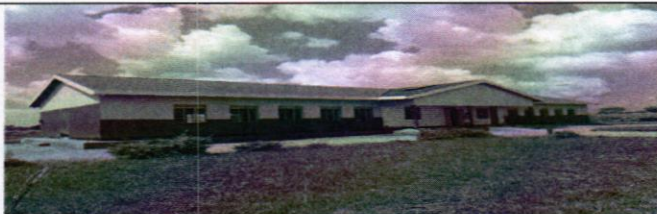
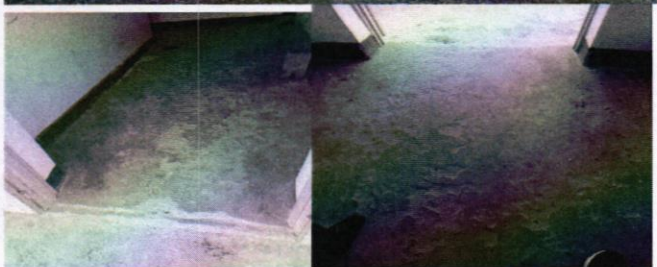
Item Description	Status of the works	Pictorial evidence
ICT and Library	<p>Pending works;</p> <ul style="list-style-type: none"> • Window glasses • Interior doors. • Furniture. • Celling cover. • Water tanks. • Ramp. • Downspout pipes. <p>Observations</p> <ul style="list-style-type: none"> • Poorly done floor screed (internal and external). • Poor quality of painting. • Weak. burglar proof in the windows. • Visible cracks on the veranda.

<p><i>Poorly done floor screed in the ICT and Library</i></p>

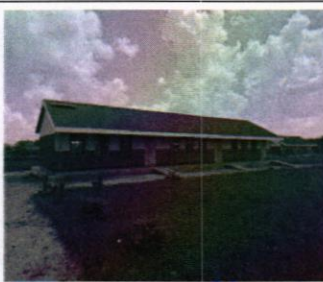
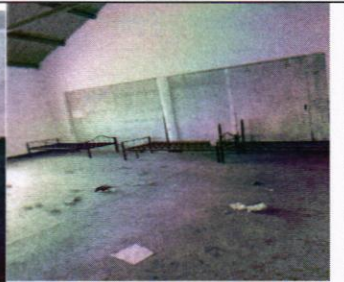
<p><i>Multipurpose hall being used as a dormitory</i></p>

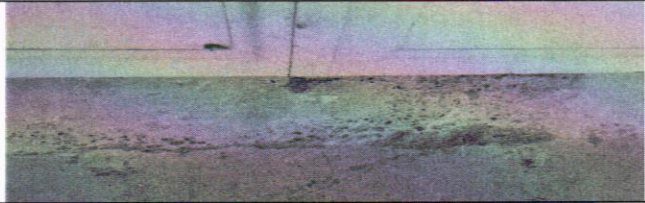
Staff houses	Pending works: <ul style="list-style-type: none"> • Gutters. • Lightening arrestor. • Sockets. • 20 interior doors. • Bathroom. • Ramps.

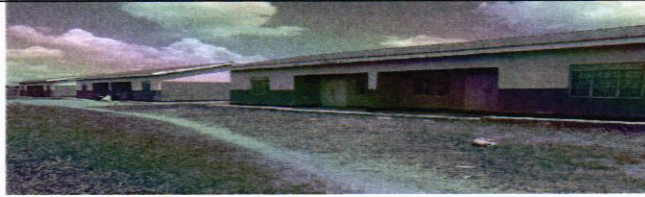
<p><i>Staff houses with no lightening arrestor</i></p>
