**CONTRACT AUDIT INTO THE CONSTRUCTION OF LAMIYO SEED
SECONDARY SCHOOL IN AGAGO DISTRICT LOCAL GOVERNMENT UNDER
UGIFT PROGRAM: PROCUREMENT REF: MOE/UGIFT/WRKS/2023/2024/00001
(LOT1)**

CONTRACTOR: NIPE CONSTRUCTION AND TECHNICAL SERVICES LIMITED

MAY 2025

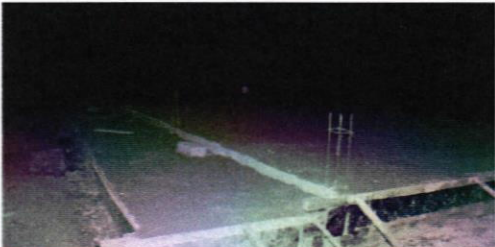
<p>The construction works of 2 – Classroom block was at slab level and the cast concrete being cured being cured.</p>
iii.	2 – Unit science laboratory block	260,014,000

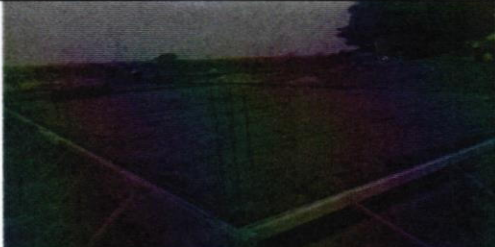
<p>The construction works of 2 – Unit science laboratory block was at slab level with polythene layed, and ready for casting concrete.</p>

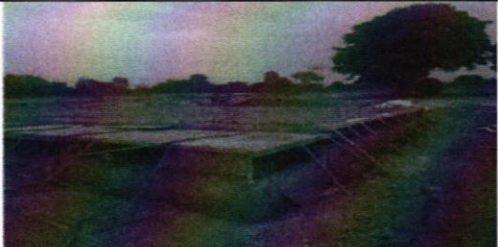
<p>The construction works of Administration block was at slab level and the cast concrete being cured.</p>

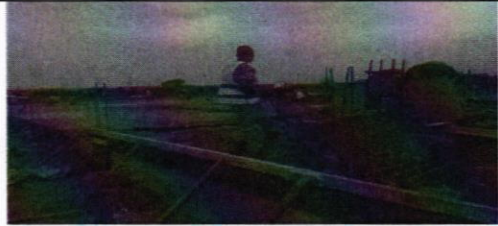
<p>The construction works of ICT –</p>

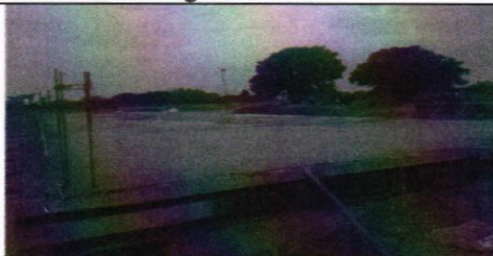
<p>The construction works of the multi-purpose hall was at slab level with concrete cast.</p>
c	Sports field	50,000,000

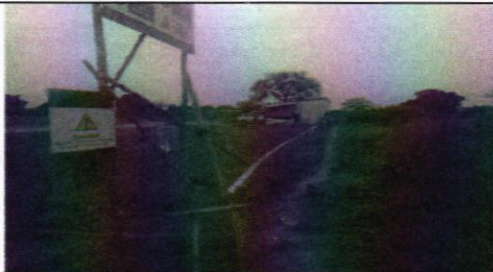
<p>The site works on the sports field located opposite the site entrance, had not started and according to the Contractor's Site Engineer, it was due to missing measurement yet to be provided by the Entity.</p>
	Total	2,276,044,950

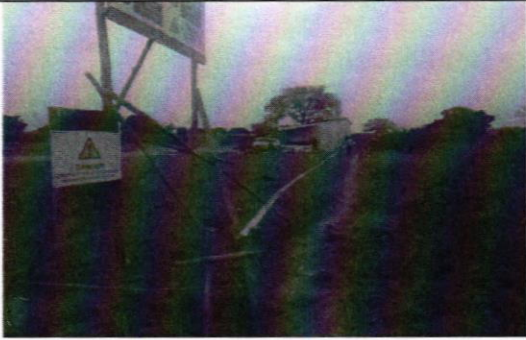
Activity not undertaken	Activity cost estimate in the BOQs (UGX)	Site visit photos to support the audit findings on 20 th December 2024.
<p>Site security (Item O): The Authority found that the site had an unsecure hoarding/temporary security fence established. The hoarding done / temporary security fence established did not cover the entire site i.e., it was incomplete and unsecure, and the site was easily accessed by anyone.</p>	2,000,000

The above security lapse, makes the site unsecure for the Contractor’s staff and also expose the construction material and equipment to risk of loss/theft. Additionally, failure to secure that project site, and with the free entry of the members of the community, the site posed safety hazard to the communities round, specifically the risk associated with the uncovered pits excavated for the pit latrines around the site.

1. Installs a gate and deploys a full-time security guard on site until completion of the project works; and
2. Secures the project site by hoarding the entire site as provided for in Items O and F under Bill 1: Preliminary and General Conditions.

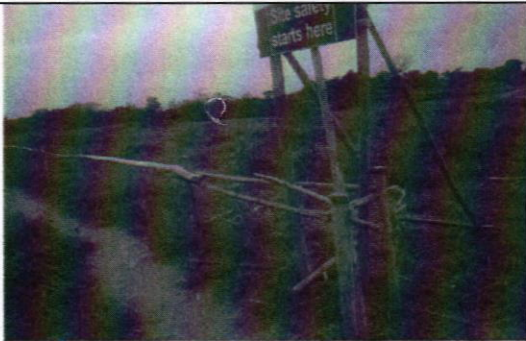
<p>Security management (Item F). The Authority found that the site security is inadequate i.e.:</p> <ul style="list-style-type: none"> • There was no gate and gate house constructed at the site; and • There were no security personnel deployed to manage the security on the site and the entrance(s). There was only a safety sign board. 	4,000,000

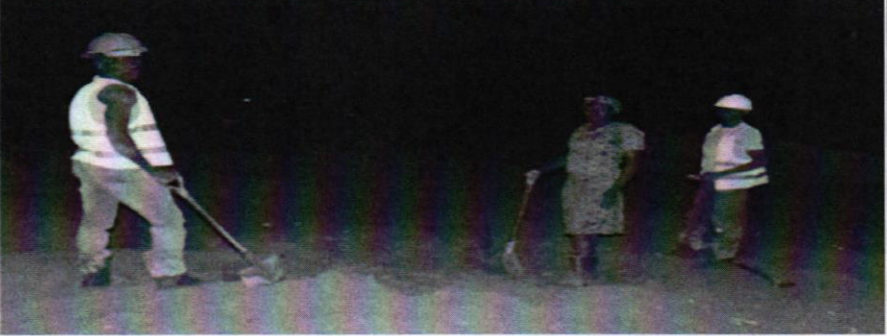
<p>The Authority found that the project personnel had insufficient PPEs as can be seen in the photo above i.e., some staff lacked hand gloves, helmets, reflector jacket, among others.</p>
Water for the project personnel	The Authority found that the site lacked a safe source of drinking water. According to the Site Engineer, the water source on site dried up, therefore the contractor collects water from outside the site.
Item I: Environment Protection: plant selected trees around the site worth UGX 3,000,000	The Authority found that the Contractor had not planted trees on the site though costed for under Item I in the B.O.Qs.

- Insufficient provision of PPEs to the site staff and visitors, exposed them to work related accidents and injury;
- Lack of a clean water source within the project site, exposed the project staff to consumption of unsafe water; and
- Failure to plant trees early on site while the contractor is on site, exposes the tree to damage and low chances of growth if planted at the end of the project without proper maintenance.

1. Provide personal protective gears to all workers on site, accordingly.
2. Secure clean drinking water source for the workers and site visitors, and install safety warnings on the site, and
3. Immediately plant trees at appropriate locations around the site for proper management and growth, while the Contractor is still implementing the project site works.
