**CONTRACT AUDIT INTO THE UPGRADE OF ACII HEALTH  
CENTRE II TO HEALTH CENTRE III IN AMOLATAR  
DISTRICT (CONTRACTOR: BUILDMAST ENGINEERING  
LIMITED)**

**AMOLATAR DISTRICT LOCAL GOVERNMENT**

**APRIL 2026**

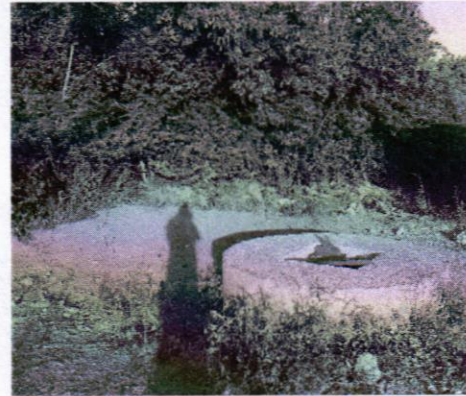
*Medical Waste pit*

**MEDICAL WASTE PIT**

Pending works included installation of mild steel lockable cover and finishes.

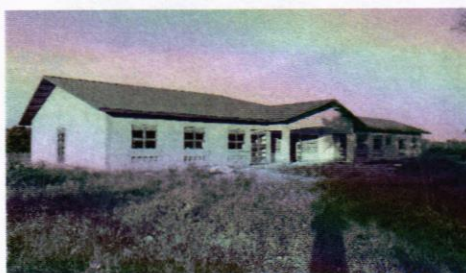
*Front View*

**MATERNITY WARD (STANDARD)**

The pending works included:

- Rainwater disposal
- Doors
- Windows
- Internal finishes
- External finishes
- Electrical installations
- Joinery fittings
- Mechanical installations

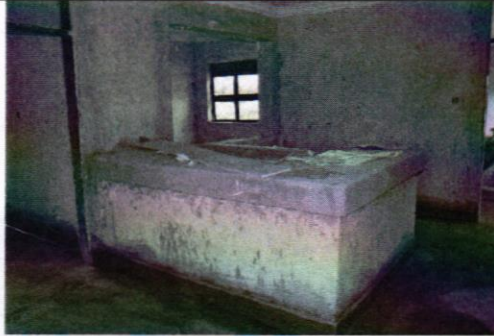
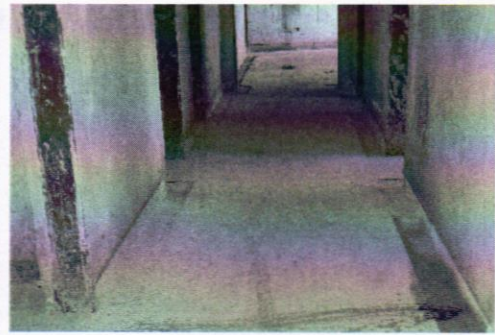
*Inside view of ongoing works inside the Maternity Ward*

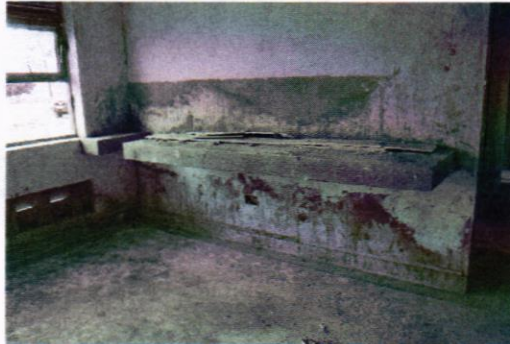
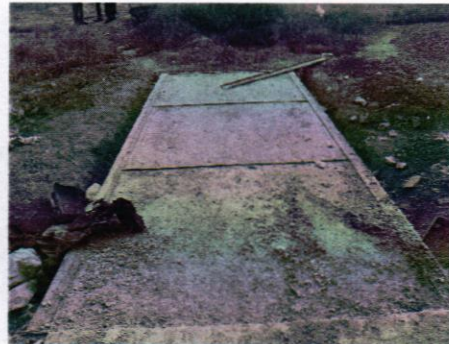
*Ongoing works inside the Maternity Ward*

*Ramp construction works*

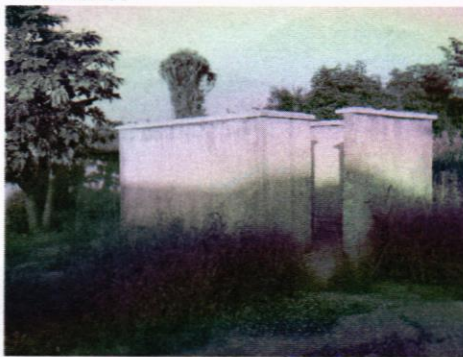
Pending works included:

- Door installation
- Splash Apron
- Finishes

*Placenta pit front view*

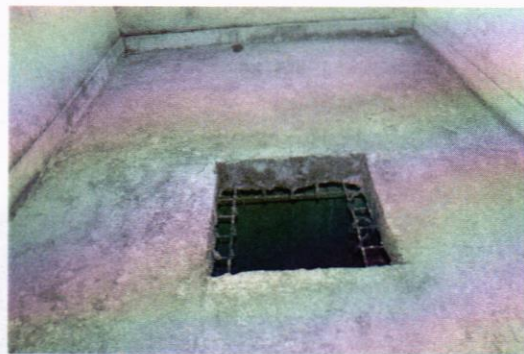
- Dangerous Site Conditions:** The site was not fenced, guarded, was poorly lit, and was overgrown with bushes. In addition, there was a total absence of safety signage, warning tapes around hazards like the open septic tank, soak pit, placenta pit, medical waste pit and more.

*uncovered pit*

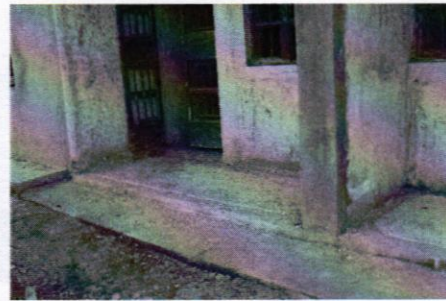
- Roofing and rain water disposal
- Doors
- Windows
- External finishes
- Internal finishes
- Joinery and fittings
- Electrical installations

- Mechanical installations

*Ongoing works at the staff house*

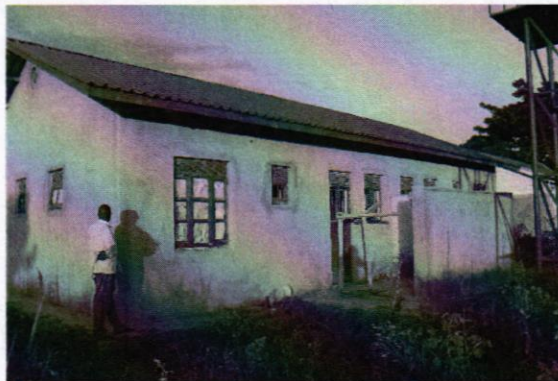
The renovation works have not commenced.

*Unrenovated OPD*

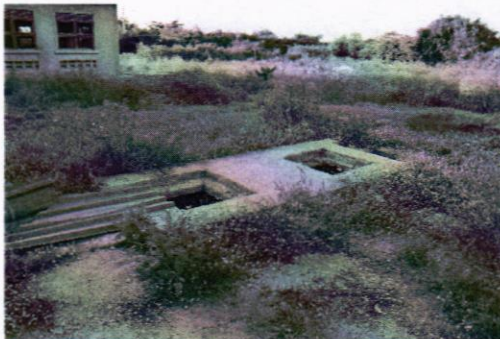
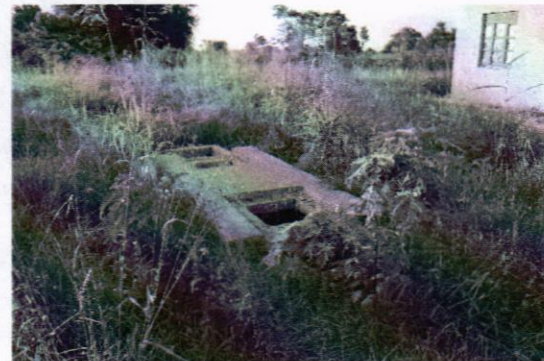
The landscaping works and site safety measures not undertaken.

*Dangerous open holes and bushy site*

1. **Commission a Forensic Structural Audit:** Direct the District Engineer to verify the strength of the existing 80% structure before any further work proceeds.
2. **Secure the Site:** immediately erect hoarding and deploy 24/7 security to halt material theft or vandalism.
3. **Hold the Project Manager Accountable:** Issue a formal inquiry to the Project Manager (District Engineer) on oversight lapses, requiring explanation for failing to conduct mandatory material strength tests, defects inspections and maintaining mandatory site documentation.
4. **Appoint a Clerk of Works:** Hire a dedicated on-site individual for daily oversight, mandating weekly progress and quality reports during the project completion phase.

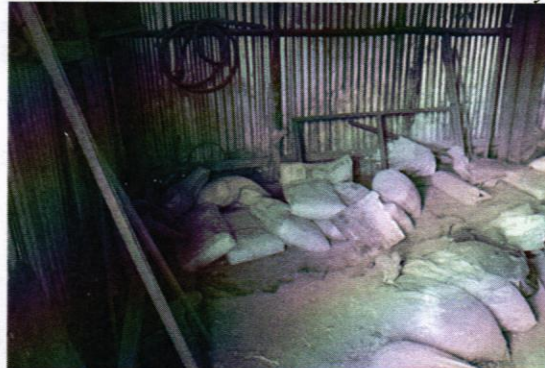
The Authority noted a total absence of material test results (e.g., concrete cube tests, soil compaction, or tensile strength tests). This lack of documentation provides no assurance that the structures possess the required durability to prevent future failure. Furthermore, there was substandard material storage i.e., the storage of cement was found to be technically negligent as the bags were stored directly on the bare floor rather than on raised wooden pallets. This exposure to ground moisture facilitates hydration, causing the cement to cake and lose its bonding strength.

*Cement stored on ground instead of a raised surface/pallets*
