**CONTRACT AUDIT INTO FOR THE CONSTRUCTION OF LWASSO SEED
SECONDARY SCHOOL IN LWASSO SUB COUNTY MBALE DISTRICT UNDER
UGIFT PROGRAM**

CONTRACTOR: MKN PAGES COMPANY LTD

PROCUREMENT REF: MOES-UgIFT/WRKS/21-22/00005-Lot 40

JANUARY 2025

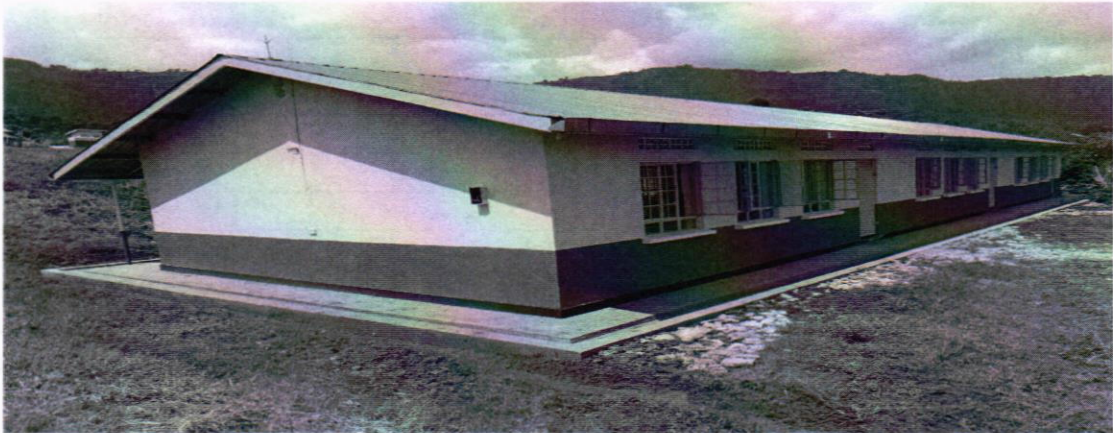
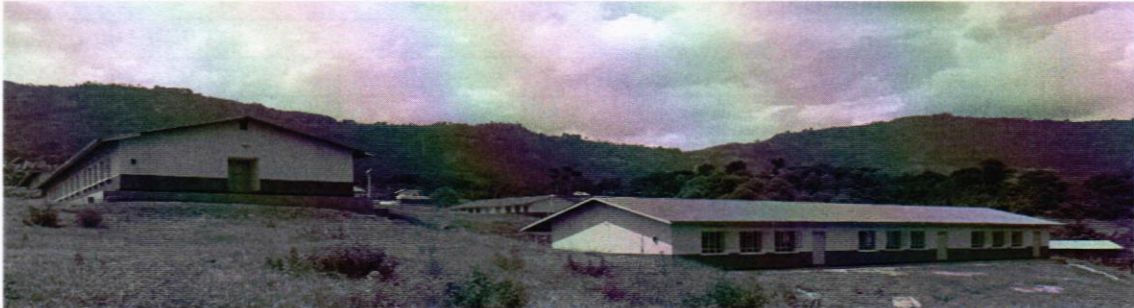
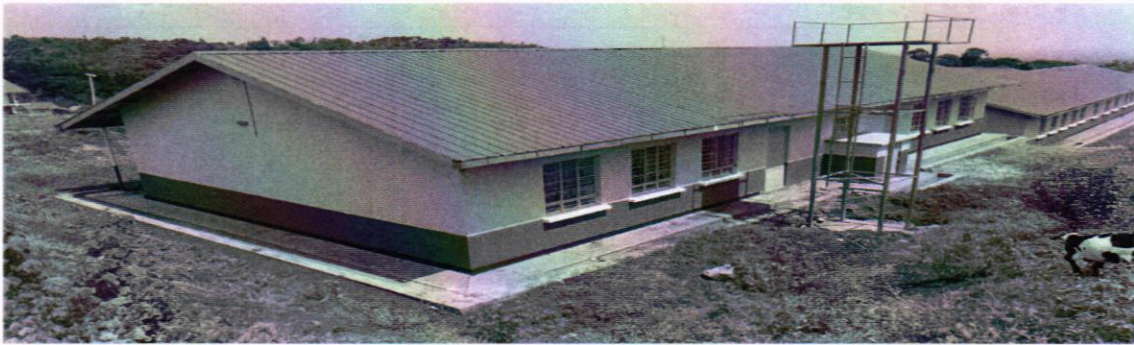
<p data-bbox="308 1346 544 1375">Classroom Blocks</p>

The contractor and the personnel were found on site and works were ongoing. Most structures had been roofed that included the classroom blocks, laboratory, Administration block, and teachers' staff houses. The football pitch works had not yet commenced due to lack of land for it. The physical progress of the project structures is shown in Table 3 below
