**CONTRACT AUDIT INTO THE PROCUREMENT OF KATIKEKILE
SEED SECONDARY SCHOOL IN MOROTO DISTRICT**

**CONTRACTORS: M/S GEOMAX ENGINEERING LTD
M/S TESO GENERAL INVESTMENT LTD
M/S KDE BUILDERS & ENGINEERS LTD
M/S DIO BUILDERS & ENGINEERS LTD**

JUNE 2023

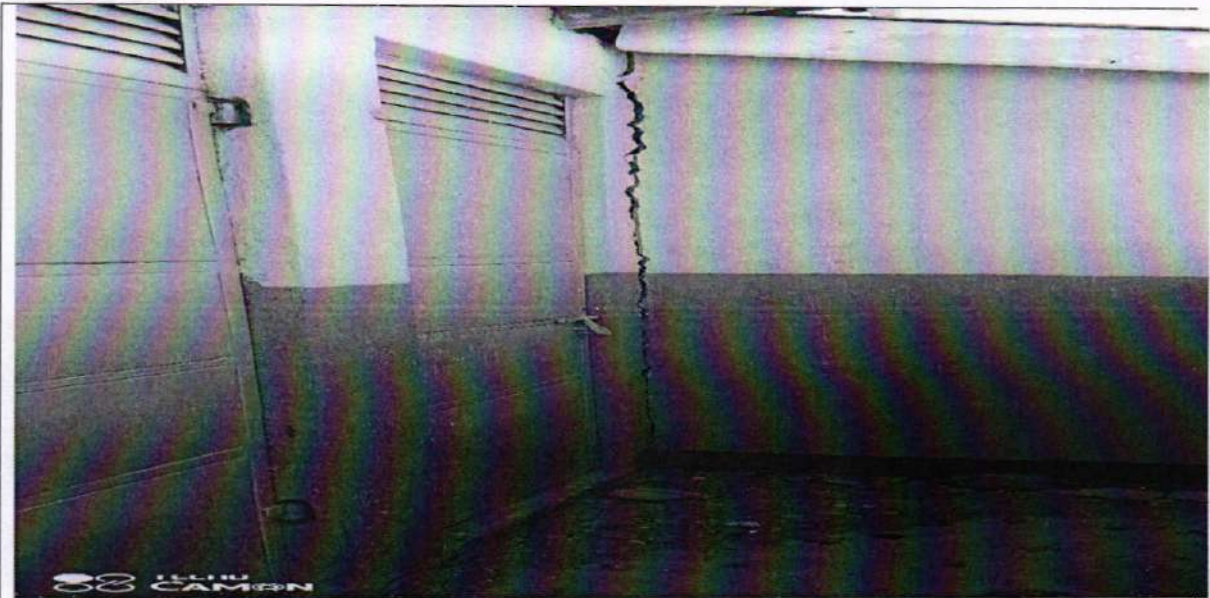
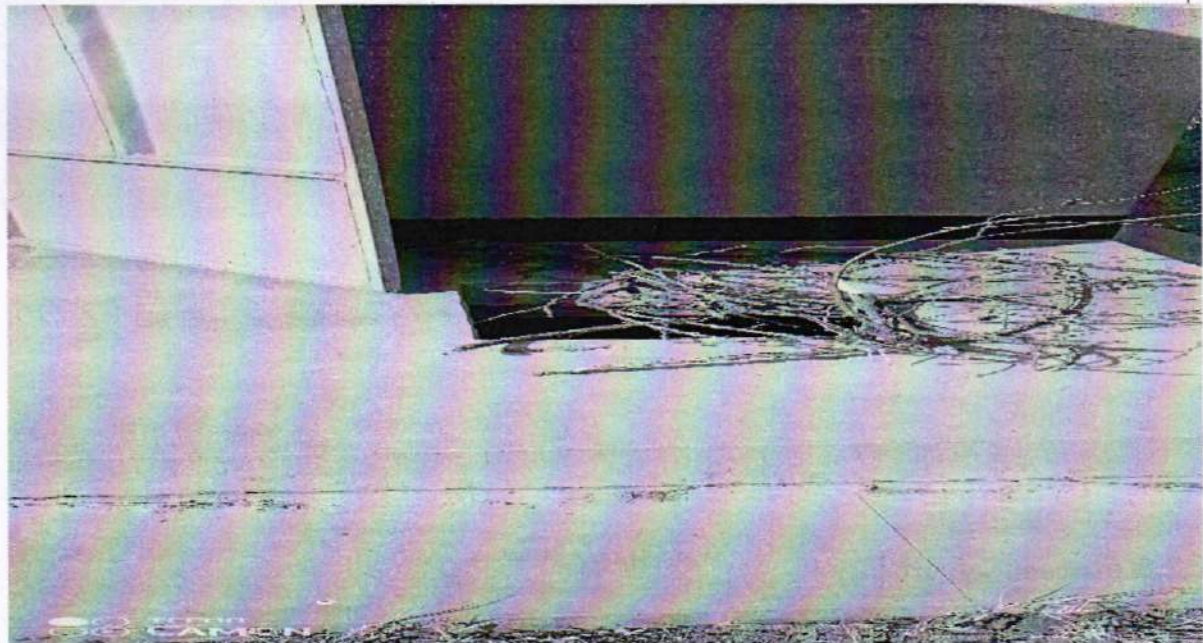
5 stance VIP Latrine for Boys and 5 stance VIP latrine for Girls

The school was found in a very sorry state with poorly maintained structures that were being used by local community to graze and keep animals. Some cracks were noted in some structures such as cracked walls of the 5 stance lined pit latrines for the boys and girls, floor the classroom blocks and the dining hall.

Findings;

- Cracks on external walls and interior walls
- Lack of man haul covers
- Open soak pits.
- Lack of wash hand tanks
- There were no labels made.

The Accounting Officer should in writing require the two contractors' M/s Geomax Engineering Uganda Limited, contractors of the 5 stance lined VIP latrine Blocks for the boys and girls respectively, and M/s Kide Builders & Engineers Ltd to fix and repair out all shoddy and maintenance works. Failure by the contractors to fix their shoddy and carry out maintenance works should cause the Accounting Officer to submit them to PPDA for black listing /suspension for shoddy works in accordance with Regulation 60 (7) of the Local Governments (PPDA) Regulations 2006.

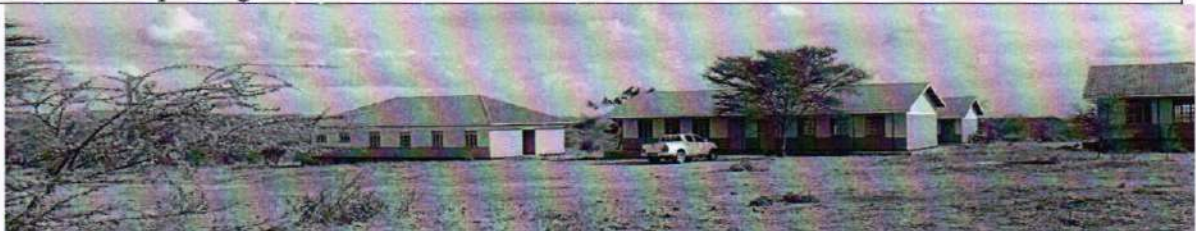
School compound and structures

Findings;

- There were no lightening conductors for the staff room, girls' dormitory, boys' dormitory, and laboratory.
- There were no rain water harvesting facilities such as gutters on all structures

- There was no fencing wall or fencing wire mesh and gate to protect the school facility.
- There were no trees planted hence no environmental measures established.

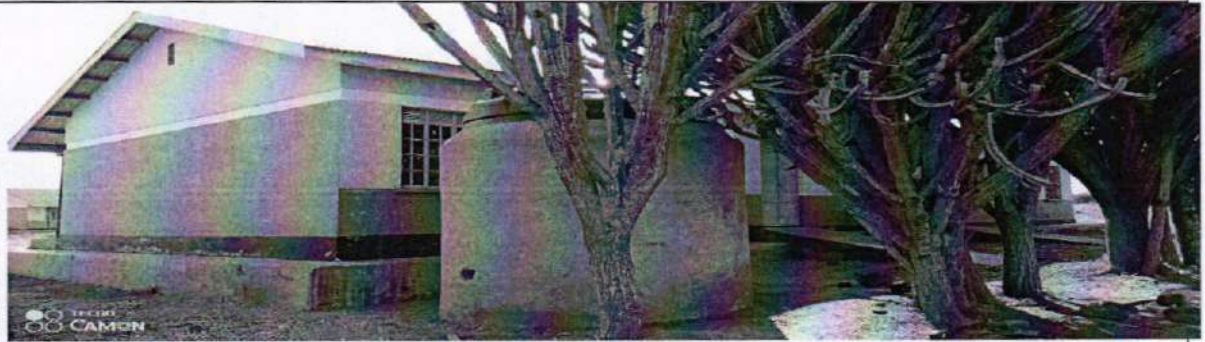
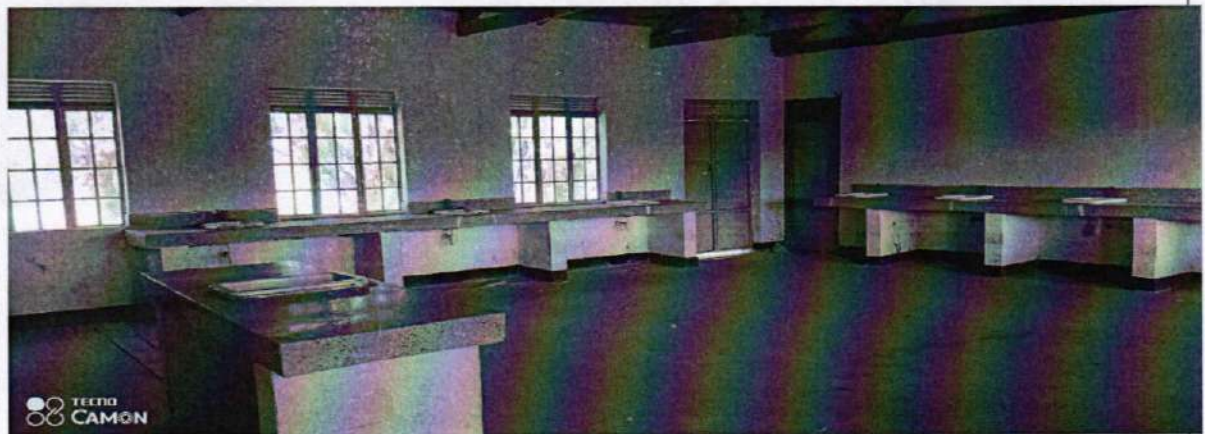
Laboratory

Findings;

- Lack of gutters and water collection pipe for the 10,000 litres tank installed
- Water taps, bunsen burner fittings, and electric installation were never installed.
- Paint was peeling off.
