**CONTRACT AUDIT REPORT ON THE REVIEW OF FOUR CONTRACTS FOR  
MINISTRY OF AGRICULTURE, ANIMAL INDUSTRY AND FISHERIES**

**UNDER  
AGRICULTURAL VALUE CHAIN DEVELOPMENT PROJECT  
FINANCED BY  
AFRICAN DEVELOPMENT BANK**

**SEPTEMBER 2026**

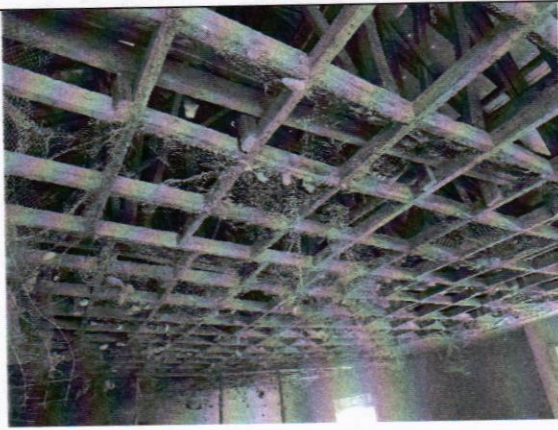
| Specific Structural Item | Auditor Observation / Defect Noted | Urgent Remedial Action Required | Photo ID No. |
|---|---|---|---|
| 3. Ceilings (Board vs. Cement) | Timber structures in the ceiling aren't strong enough to withhold loading from roof | Additional timber members needed.<br><br>Also recommended to use cement boards instead. | |

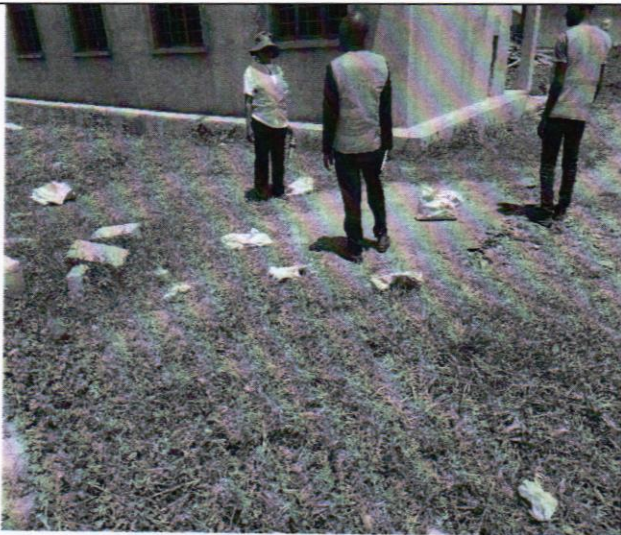
| 3. Site Housekeeping / Rubbish | Poor house-keeping noticed in front of the administration block | | |

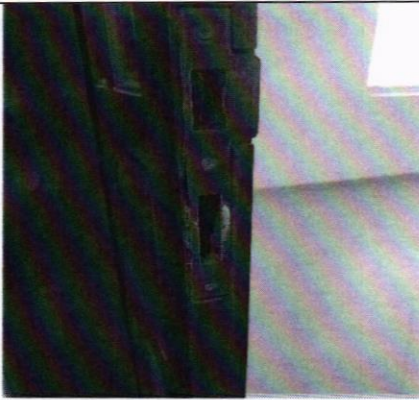
| <b>5. Joinery<br/>(Doors,<br/>Windows)</b> | <ul style="list-style-type: none"> <li>Faulty strike plates on doors of administration block</li> </ul> | <ul style="list-style-type: none"> <li>Make good all faulty strike plates of the doors of administration block</li> </ul> | |

The CMT should formally issue a comprehensive snags list instructing the contractor to seal wall and floor openings, replace corroded junior staff fixtures, relocate door stoppers, rectify faulty strike plates, repaint blistered walls, prime rusty fence poles, and replace cracked paving stones before the defects liability period expires.

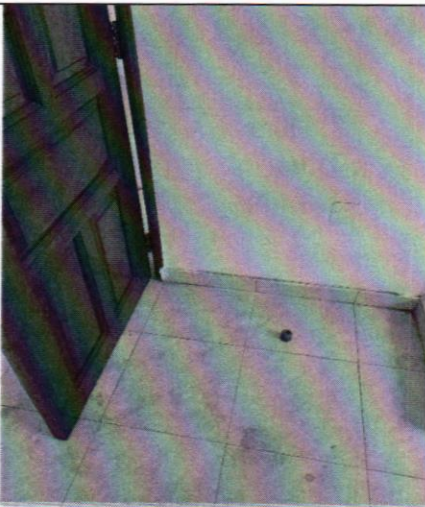
| | <ul style="list-style-type: none"> <li>Door stoppers placed in unsuitable positions</li> </ul> | <ul style="list-style-type: none"> <li>Relocation of door stoppers to suitable position behind the doors</li> </ul> | |

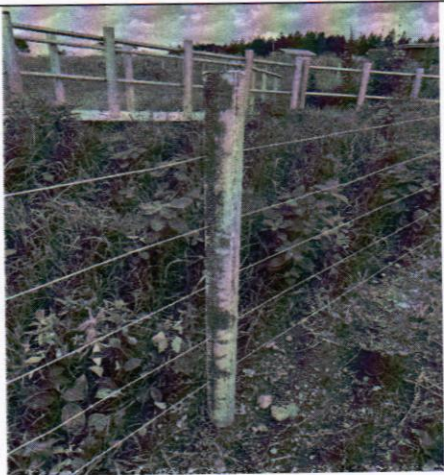
| Specific Engineering Item | Auditor Observation / Defect Noted | Urgent Remedial Action Required | Photo ID No. |
|---|---|---|---|
| 3. Boundary Fencing / Chains | Rusty steel poles observed along drawn wire fencing | Remove suitable method of rust removal, clean the surface, apply metal primer and paint the exterior surface. | |

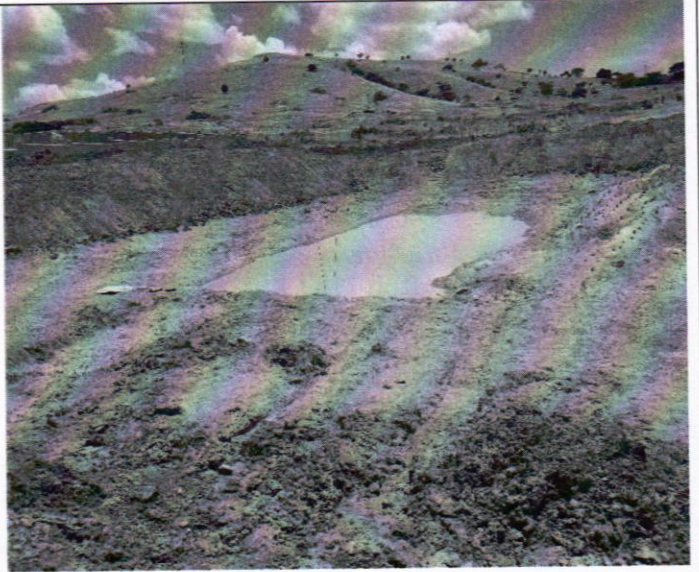
| <b>Specific Engineering Item</b> | <b>Auditor Observation / Defect Noted</b> | <b>Urgent Remedial Action Required</b> | <b>Photo ID No.</b> |
|---|---|---|---|
| 2. Excavation | Some excavation points are left open without any warning tape | | |

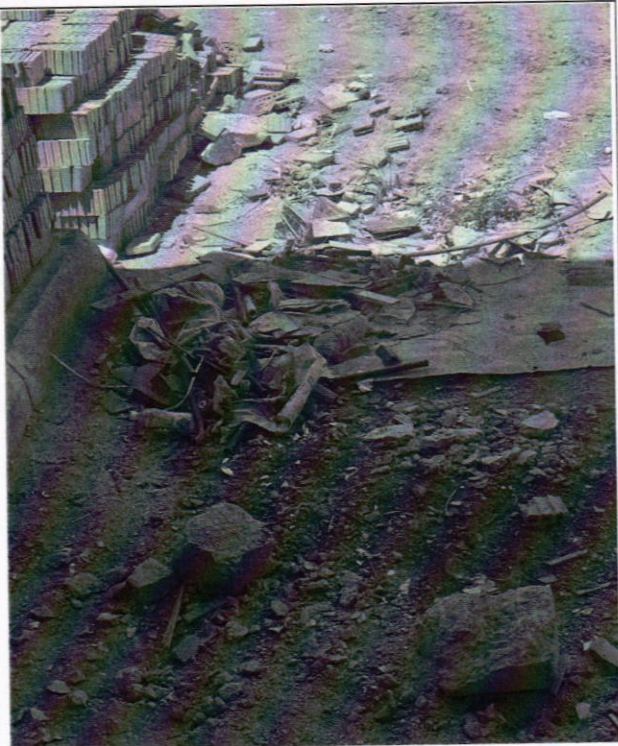
| Observation Parameter | Auditor Observation / Defect Noted | Urgent Remedial Action Required | Photo ID No. |
|---|---|---|---|
| 3. Site Housekeeping / Rubbish | Poor house-keeping noticed all around the site | | |

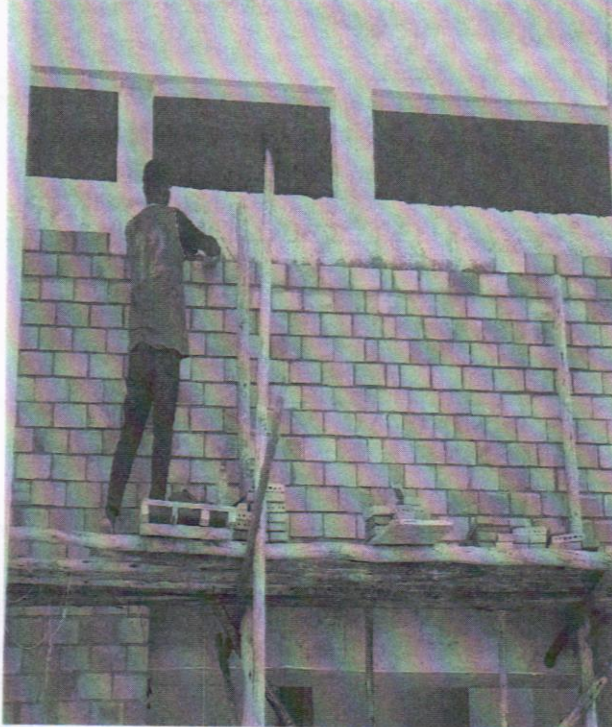
| 5.Compliance to PPE's | staff sighted working without full PPE's | Adhere to strict compliance to the full PPE's | |

The Authority noted that the use of PPE had some level of laxity as several workers lacked hard hats and one person was seen welding without any protective gloves or protective eye goggles during a field inspection on 9<sup>th</sup> April 2026. The site had several excavations that were unattended to including a valley tank with some collected water. These did not have any warning notices/ Signage's or tapes. Tree cutting affected cover of the area as 44 trees were cut. The replacement had not started at the time of the visit and the NEMA certificate was not obtained.

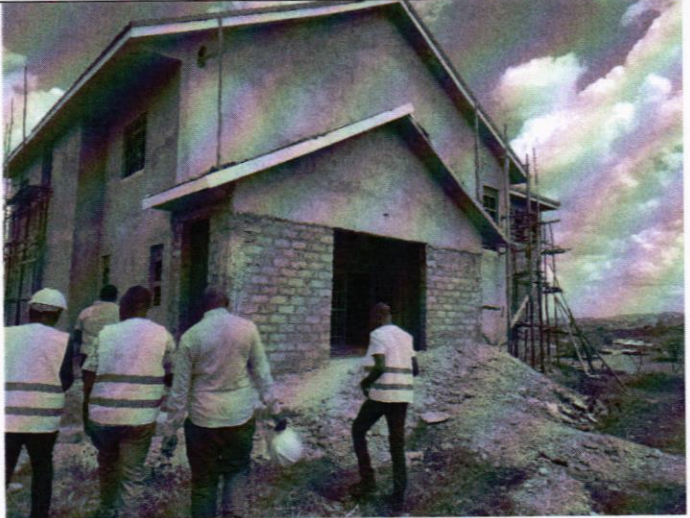
| Specific Engineering Item | Auditor Observation / Defect Noted | Urgent Remedial Action Required | Photo ID No. |
|---|---|---|---|
| 2. Loose Soil Heaps | Loose heaps of sand noted at the entrance of administration block | Remove all loose soil heaps | |
