**PUBLIC PROCUREMENT AND DISPOSAL  
OF PUBLIC ASSETS AUTHORITY**

**CONTRACT AUDIT REPORT INTO THE CONSTRUCTION  
WORKS OF THE UPGRADE OF TE-TUGU HEALTH CENTRE  
III (CONTRACTOR: WML CONSULT & ENGINEERING  
LIMITED); AND FENCING OF ATABU HEALTH CENTRE II  
(CONTRACTOR: DREAMERS ENTERPRISES LIMITED)**

**DOKOLO DISTRICT LOCAL GOVERNMENT**

**APRIL 2026**

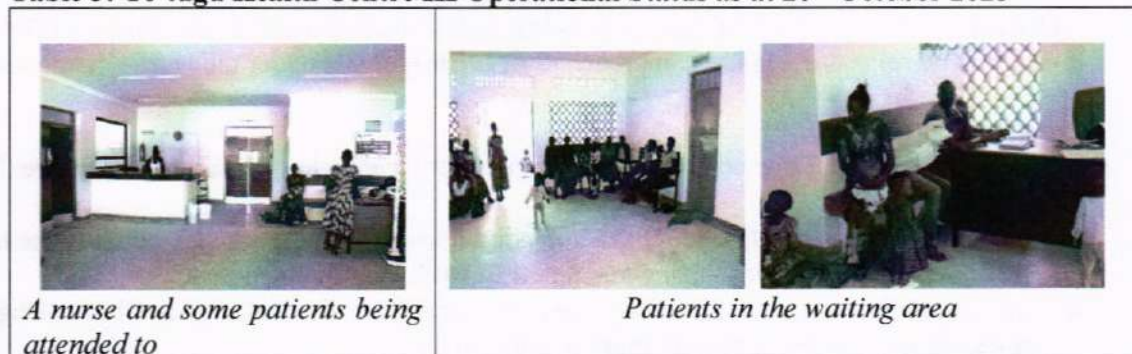
**Table 3: Te-tugu Health Centre III Operational Status as at 20<sup>th</sup> October 2025**

During an inspection on 20<sup>th</sup> October 2025, the Authority verified that the facility was operational, with hospital staff attending to patients in the waiting areas as shown in Table 3 below.

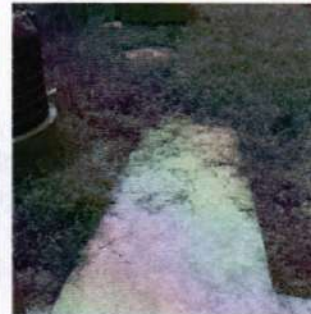
- ii) **Safety and Accessibility Lapses:** Ramps were not levelled to the ground, creating trip hazards. Furthermore, the omission of PWDs-specific grab rails denies inclusive access to the health facility.

*Women's toilet entrance with ramp covered by grass hindering easy access by PWDs*

*Management notes the observations. Nonetheless, accessibility issues, ramp levelling, and missing grab rails, have persisted due to the contractor's reluctance to fully comply. The contractor has been formally instructed to rectify the painting defects, including applying a second coat and correcting bubbles, to meet the required standards.*
